Subj: Report entitled "Health Physics Activities in Connection with the Disestablishment of MRDL: Disposal of Radioactive Material and Termination of AEC Licenses"; forwarding of

HEALTH PHYSICS ACTIVITIES IN CONNECTION WITH THE
DISESTABLISHMENT OF NRDL: DISPOSAL OF RADIOACTIVE
MATERIAL AND TERMINATION OF AEC LICENSES

31 December 1969

SAN FRANCISCO BAY NAVAL SHIPYARD, NRDL DISESTABLISHMENT GROUP
San Francisco, California 94135

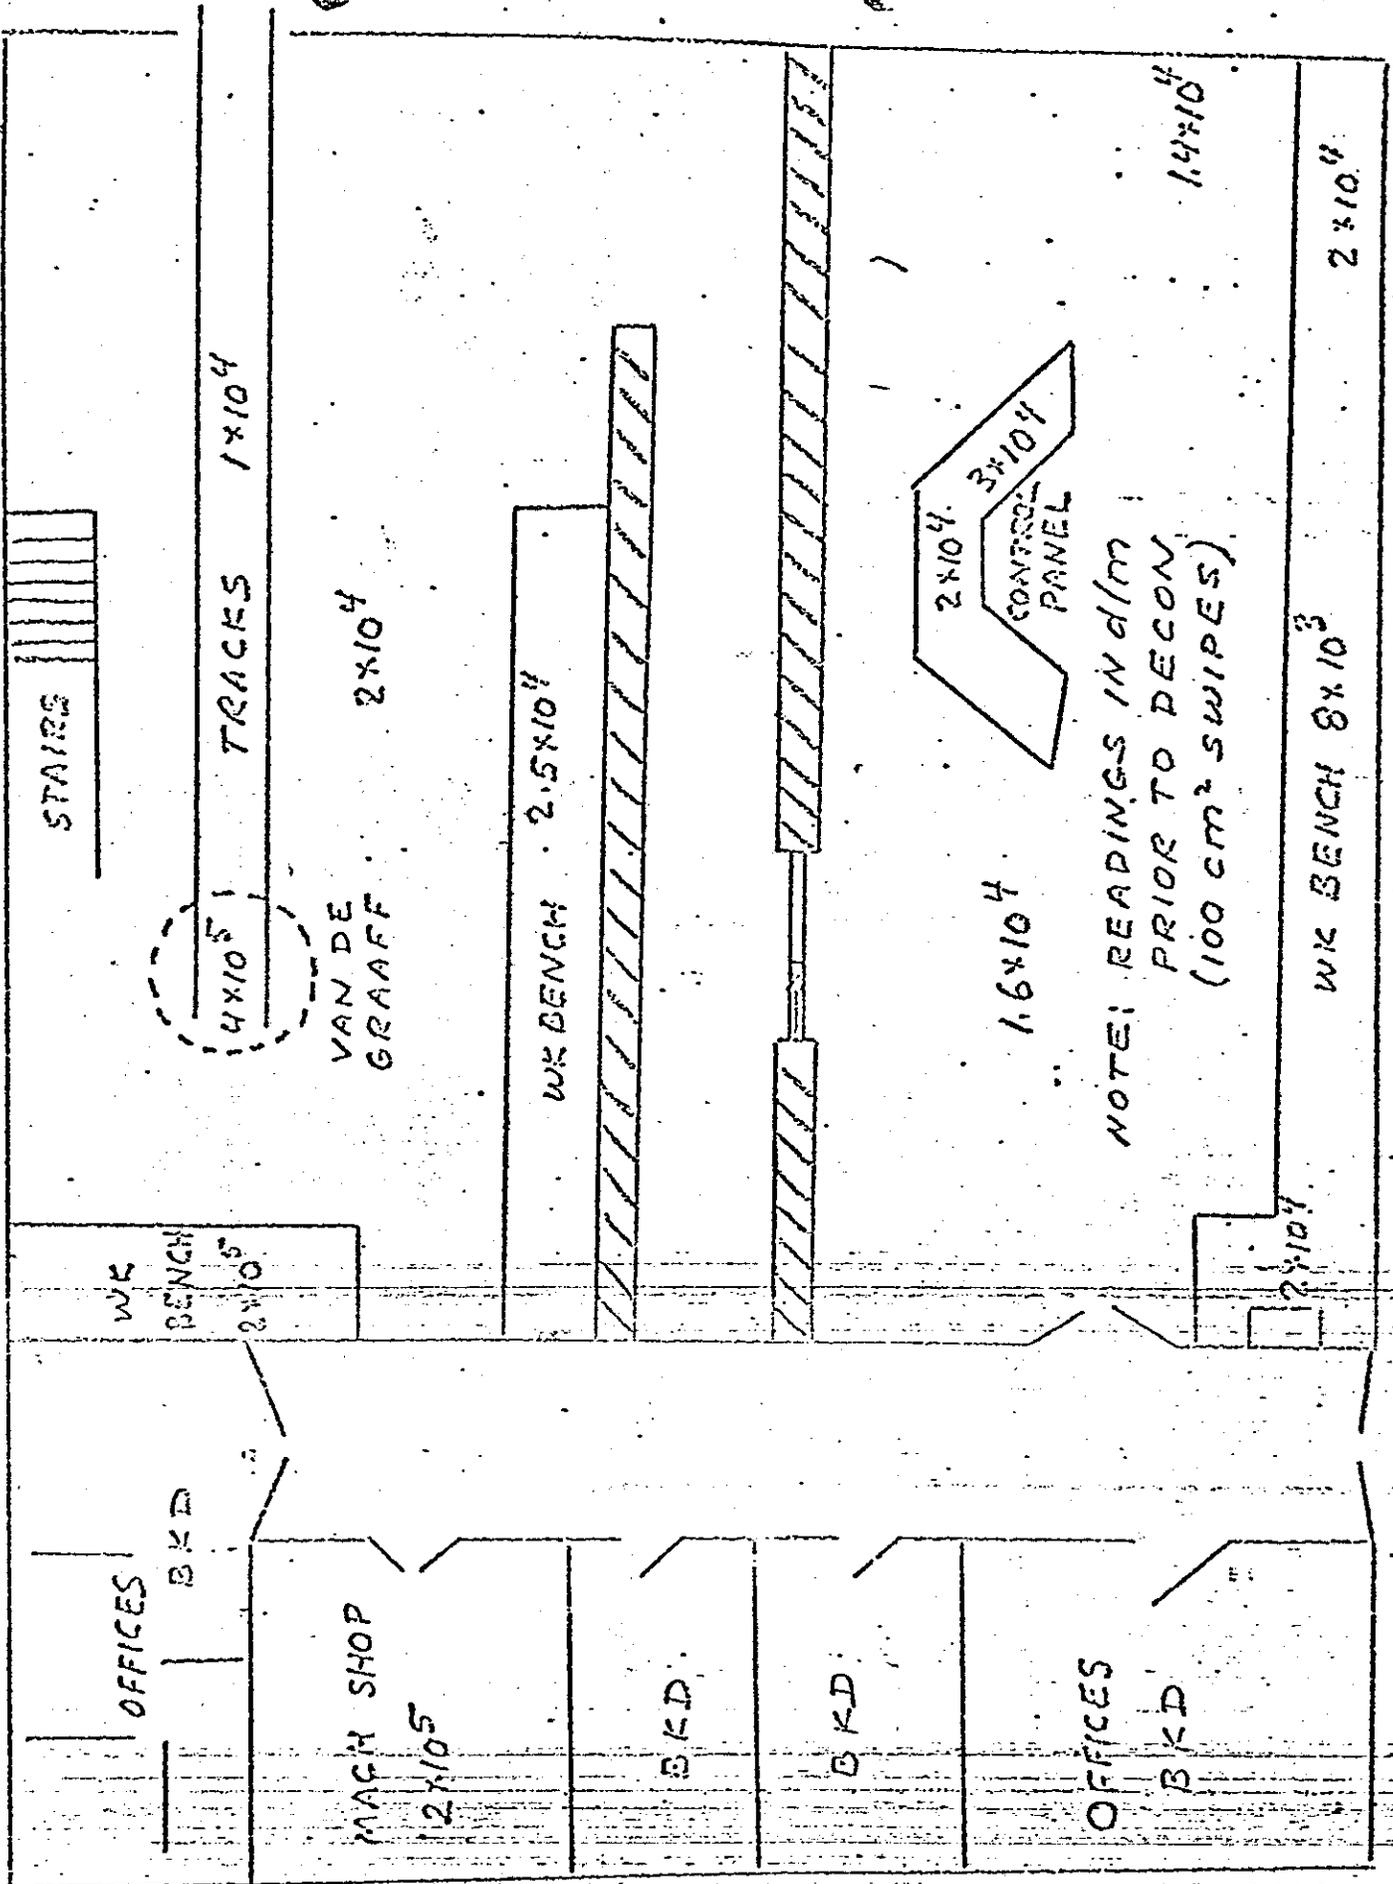
FIGURE 4. PRIMUM SWIPES BLDG B1A 1ST DECK

This building contained the 2-MeV Van de Graaff (VDG) accelerator which was used to accelerate either electrons or positive ions. No radiation sources other than sealed Pu-Be neutron standards were used in this building. The primary source of radiation contamination was from tritium targets used to produce neutrons when bombarded with protons or deuterons. Radiation surveys were initially made with a portable G-M survey instrument. No radioactive contamination was detected by this method. However, swipes counted with a tritium-carbon (TRICARS) scintillation detector showed extensive tritium contamination. The counts generally ranged from 10^4 to 10^5 disintegrations per minute. Figures 1

and 2 give the results of swipe tests made on the first and second floor. Additional swipes were made in the Butler Building Annex which contained a large open pit that was used to provide a scatter-free environment for neutron experiments. Beam pipes were used to extend the VDG beam over the pit. Readings of up to 10^5 dpm were obtained from swipes taken on the metal grating directly below the neutron target. Readings up to 3×10^4 dpm were obtained on the pit floor. Swipes taken in the remainder of the building read background.

Following removal of the VDG accelerator and auxiliary equipment the building was steam cleaned for removal of tritium in the concrete walls and floors. Tritium is readily absorbed on porous surfaces and can be driven off into the atmosphere by a combination of heat and high humidity. Swipes were made after the steam cleaning operation in all contaminated areas of Fig. 1 and 2, and in the remainder of the building, including the annex. All counts registered background indicating that the tritium had been successfully removed. An AEC inspection made on Nov 19 indicated no detectable tritium contamination.

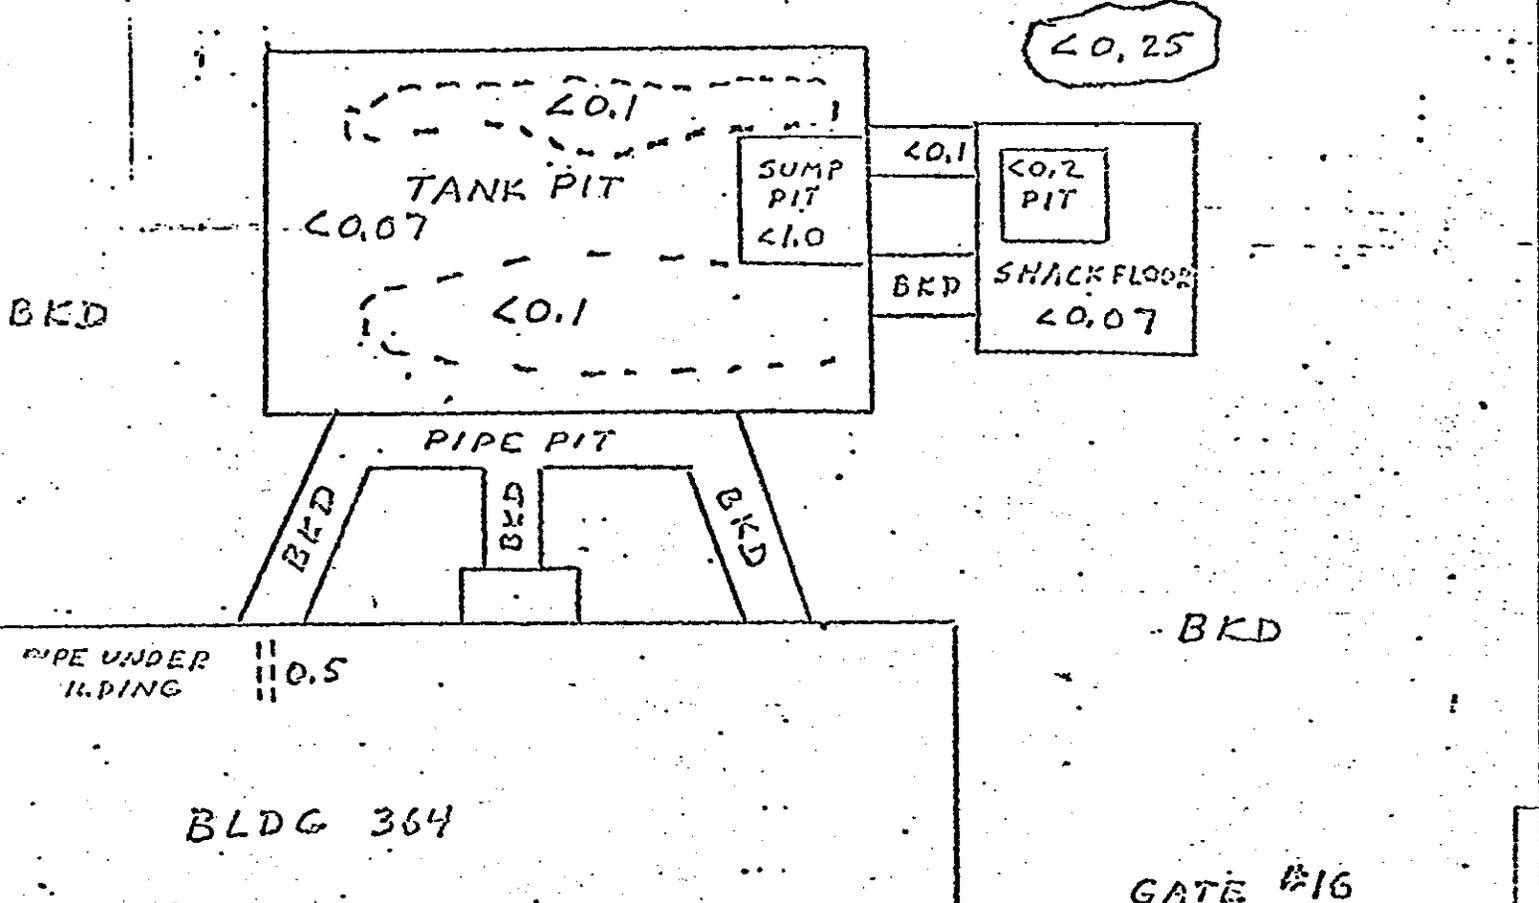
FIGURE 3

Radiation levels on the shack floor of the pump shed ranged from 4-6 mr/hr and in the sump pit from 15-20 mr/hr. Decontamination consisted of tearing down the pump shed and all associated plumbing, including the pipes leading to the tank pit. Chipping operations were then performed on the concrete floor and sump pit. Final radiation levels were less than 0.07 mr/hr on the floor and less than 0.2 mr/hr in the sump. Low level activity of less than 0.2 mr/hr was also found in several locations

throughout the yard (see Fig. 3) where radioactive waste had been stored.

All plumbing from Bldg 364 to the tank pit was removed. One piece of pipe going into a concrete slab under the building read 0.5 mr/hr. The other end of the pipe connected to Room 108, originally the decontamination room. The drain which was several feet below floor level had been covered up with sand and a top layer of concrete. In order to determine radiation levels on this end of the pipe, the floor was broken and the sand removed from the drain sump. Location of the drain is shown in Figure 4. Radiation levels on the bottom of the drains were a maximum of 0.07 mr/hr. Following discussions with the AEC it was decided to leave the pipe in the concrete slab. However, their recommendation was that the hole be filled in. This presented no problem since the shipyard had already stated that the concrete floor was to be restored. Some contamination was also detected on the walls of Room 108; this was readily removed by washing down with detergent and water.

FINAL RADIATION LEVELS OUTSIDE OF BLDG 364

Small amounts of radioactive contamination remain in the yard area behind Bldg 364. These are primarily on the floor of the concrete tank pit and on the shack floor slab. Location of the remaining beta-gamma activity in the yard area may be found in Figure 3.

One pipe under Bldg 364 read 0.5 mr/hr (see Fig. 3). There is no detectable radioactive material remaining in the building.

Radiation levels on the floor and lower walls of the tank pit averaged greater than one mr/hr, while readings in the sump pit were as high as 5 mr/hr. The pit was decontaminated by chipping the surface concrete until radiation levels and swipe counts decreased below permissible AEC levels. Figure 3 gives the radiation levels outside of Bldg. 364 upon completion of decontamination activities. These averaged less than 0.1 mr/hr on the tank pit floor and less than 1 mr/hr in the sump pit.

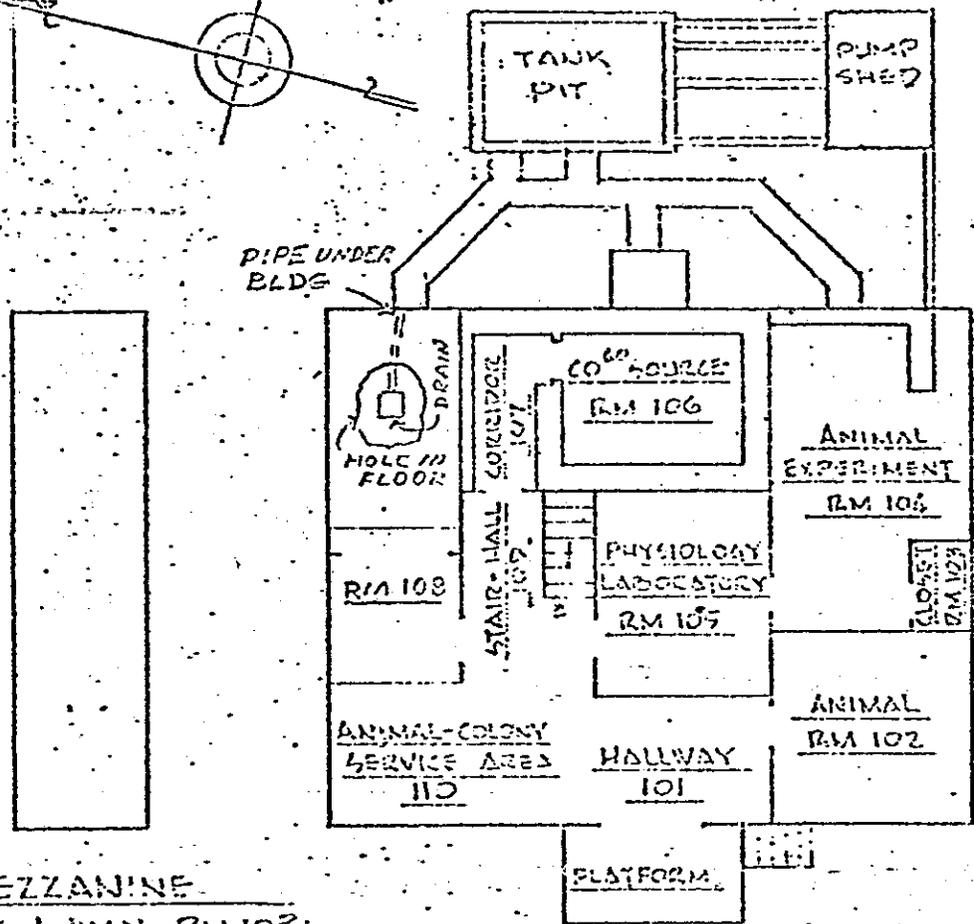
FIGURE 4

Radiation surveys and swipes were made in the remaining rooms of the first floor and mezzanine (see Figure 4). No detectable radiation was found.
