**ARCHEOLOGICAL INVENTORY  
AND ASSESSMENT OF  
HUNTERS POINT SHIPYARD  
SAN FRANCISCO COUNTY, CALIFORNIA**

**FINAL REPORT**

**Engineering Field Activity, West  
Naval Facilities Engineering Command  
900 Commodore Drive  
San Bruno, CA 94066-5006**

*February 1998*

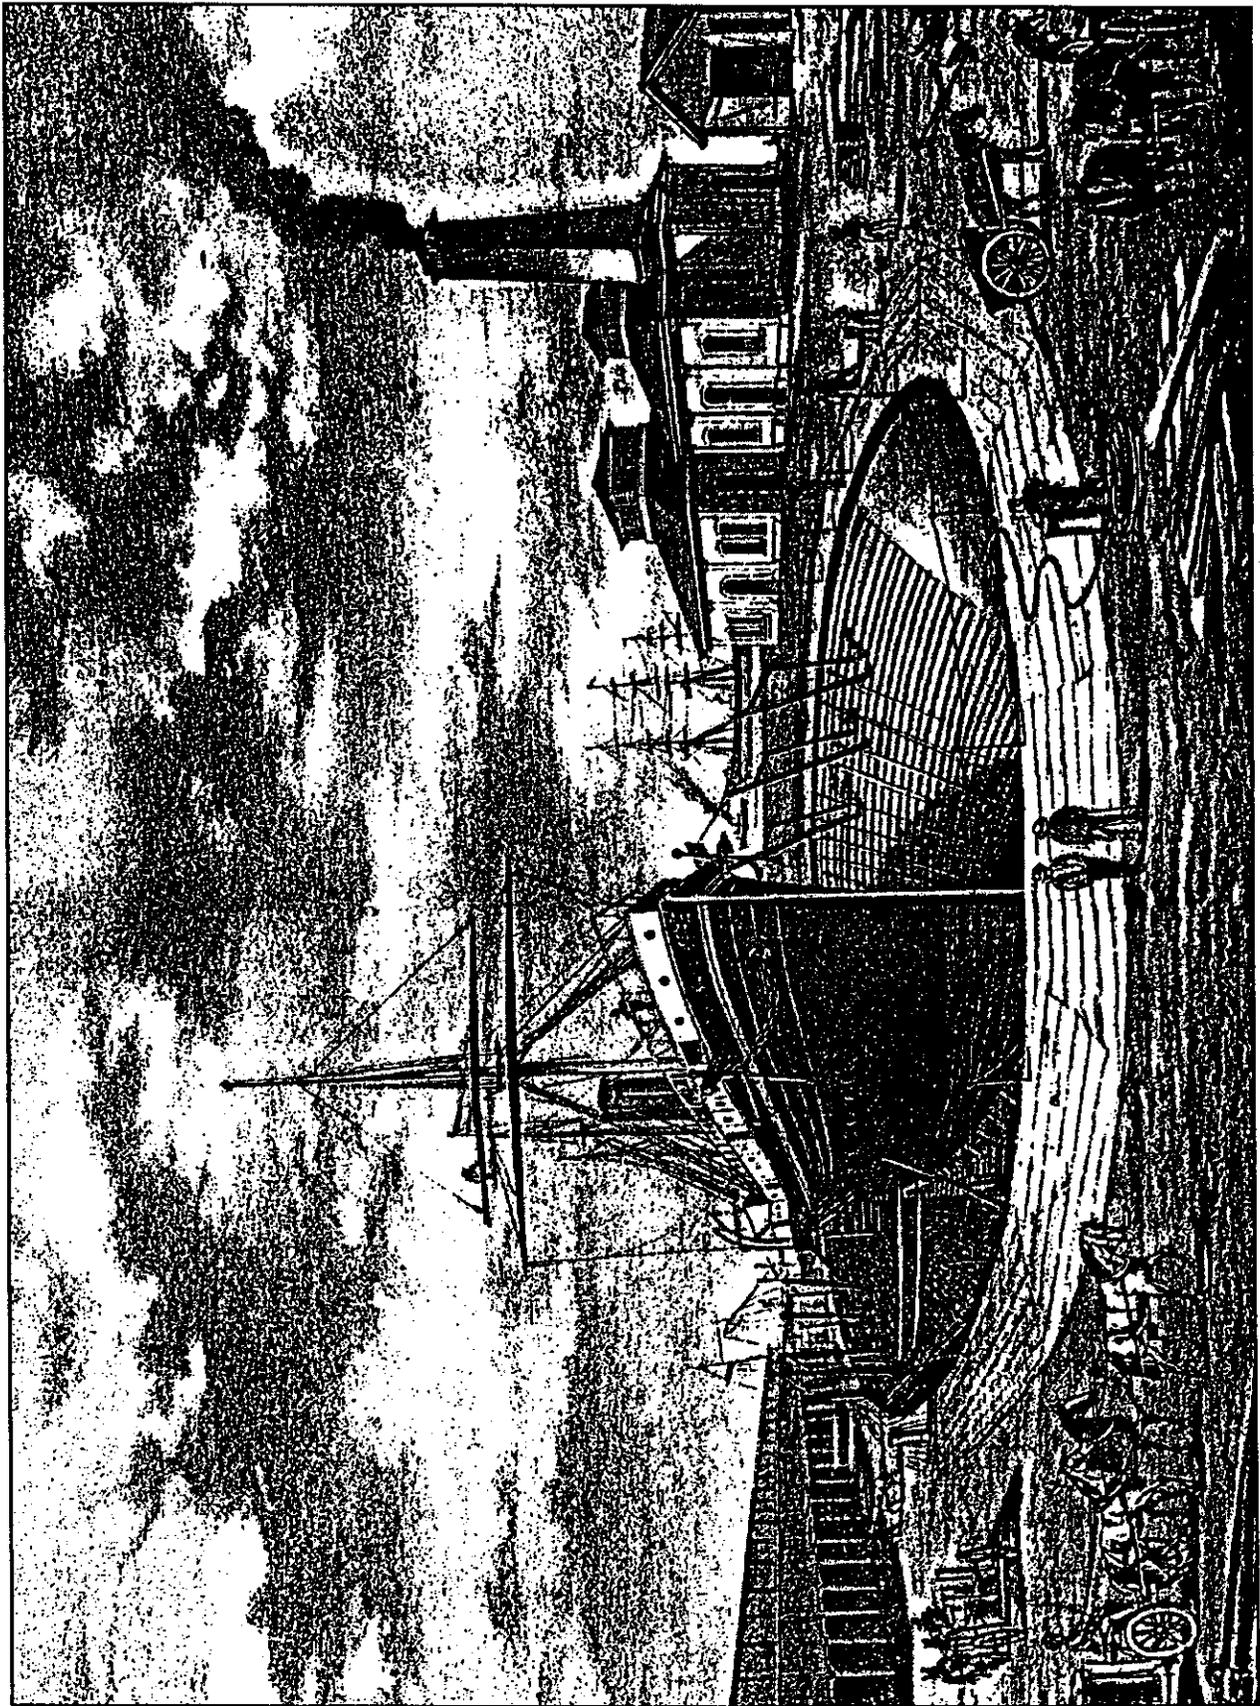
Figure 3. Dry Dock No. 1, circa 1876

In 1863, the South San Francisco Drydock Company bought the easternmost portion of the point with plans to construct a dry dock (Bamburg 1988:14; McKeon n.d.:5). A pier and docking facilities had been constructed by 1867, when the California Dry Dock Company purchased the tip of the point for a graving dock. The company hired engineer Alexis Von Schmidt to design and supervise construction of the dry dock. When complete in 1868, it was 490 feet long and later became known as Dry Dock No. 1 (Figure 3). Its pump house could drain the dry dock in two hours, a major improvement over the other floating dock facilities in the Bay Area. In addition to private ships, the U. S. Navy also used the Hunters Point dry dock facility for ships with too great a draft to move up the strait to reach the Mare Island Naval Yard (Bamburg 1988:3-4). By 1870, the dry dock and several outbuildings and sheds

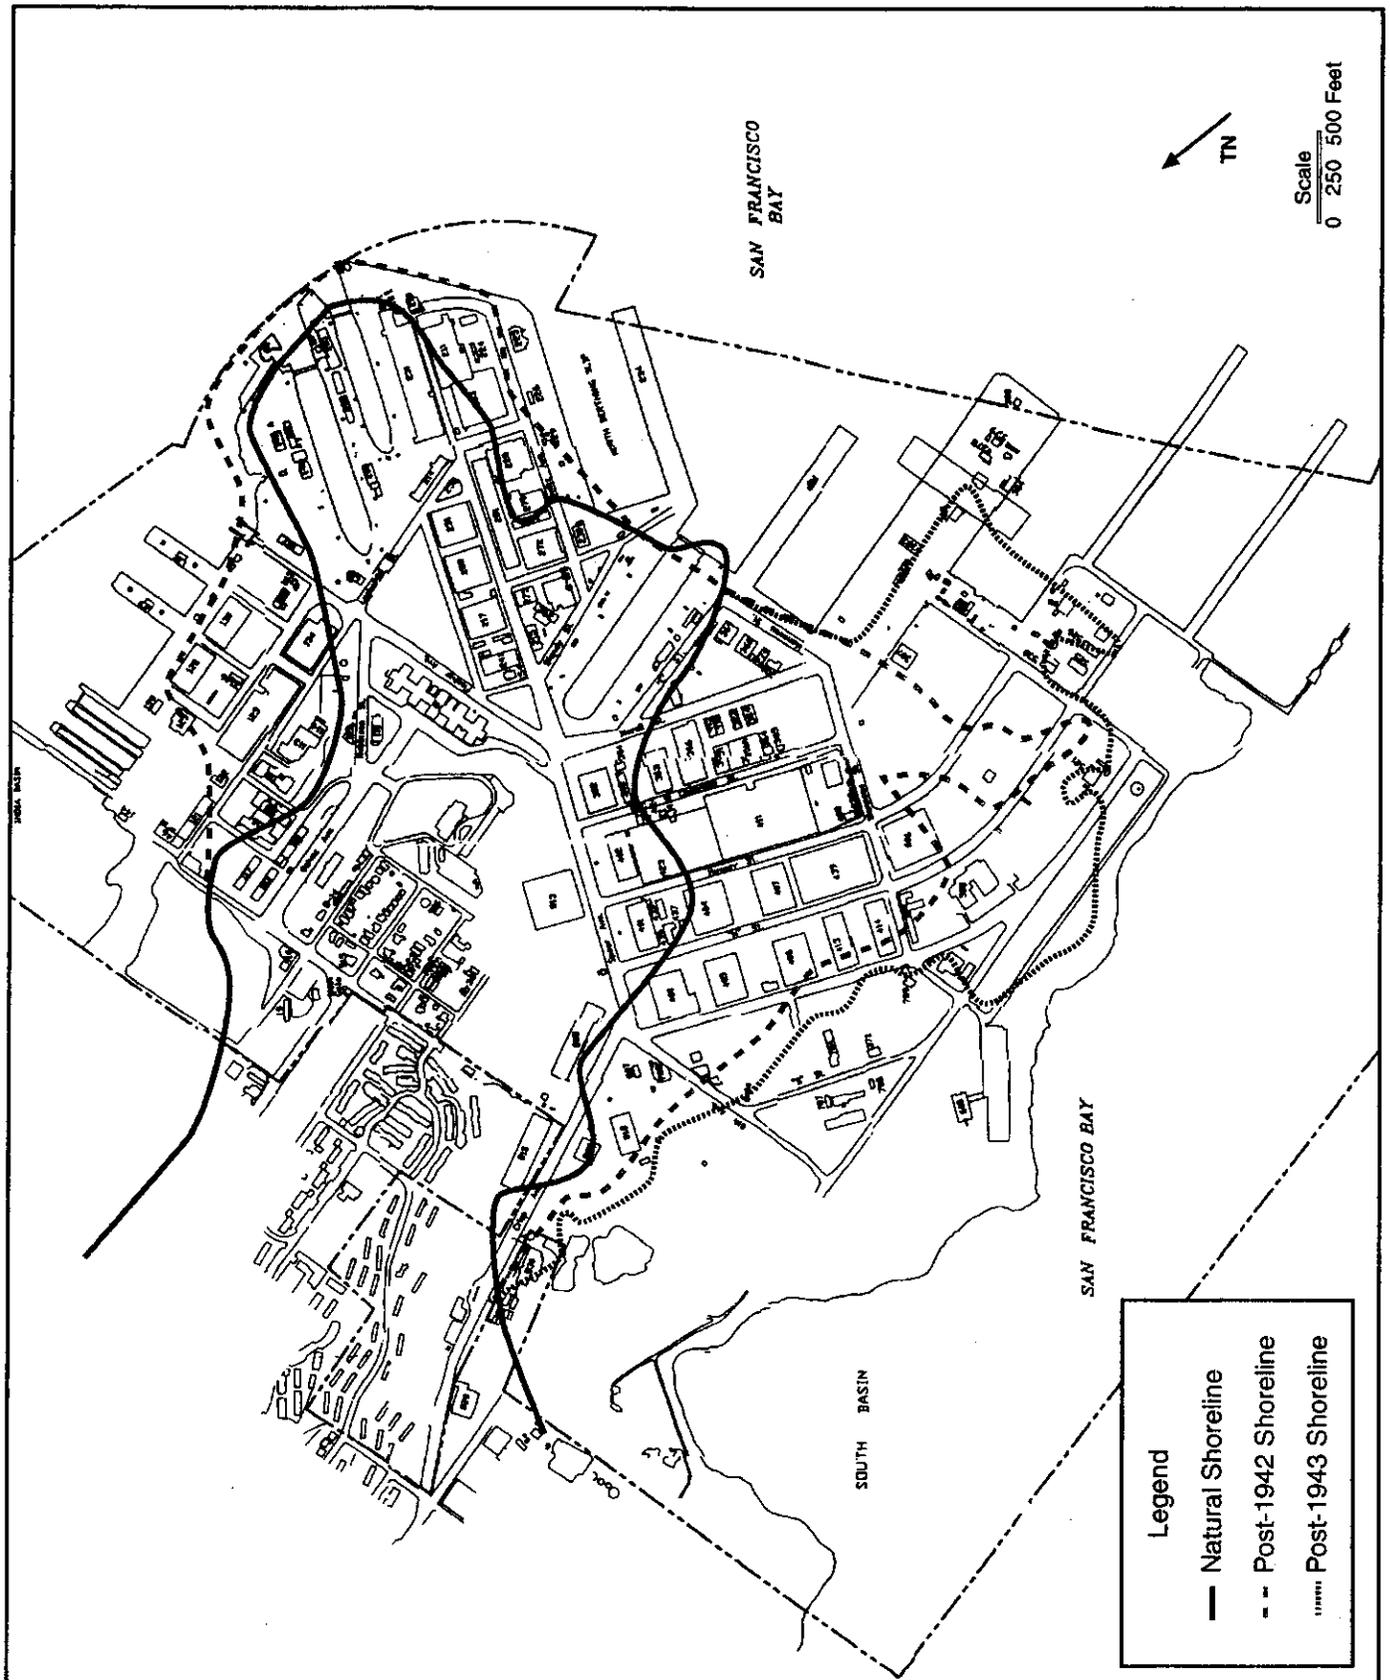
Figure 13. Shoreline Alterations at Hunters Point

The difficulties noted above are compounded by the fact that since the mid-1860s numerous changes have taken place to the natural landform of Hunters Point. Pastron notes that the prehistoric sites noted by Nelson as CA-SFr-11, -12, -13 and -14, would have been originally located either at the upper edge of the tidal affected lands, or directly associated with upland, dry, locations on Hunters Point. An in-depth discussion regarding the possible location of these sites will be presented in a later section of this report (see Predicted Archeological Features).

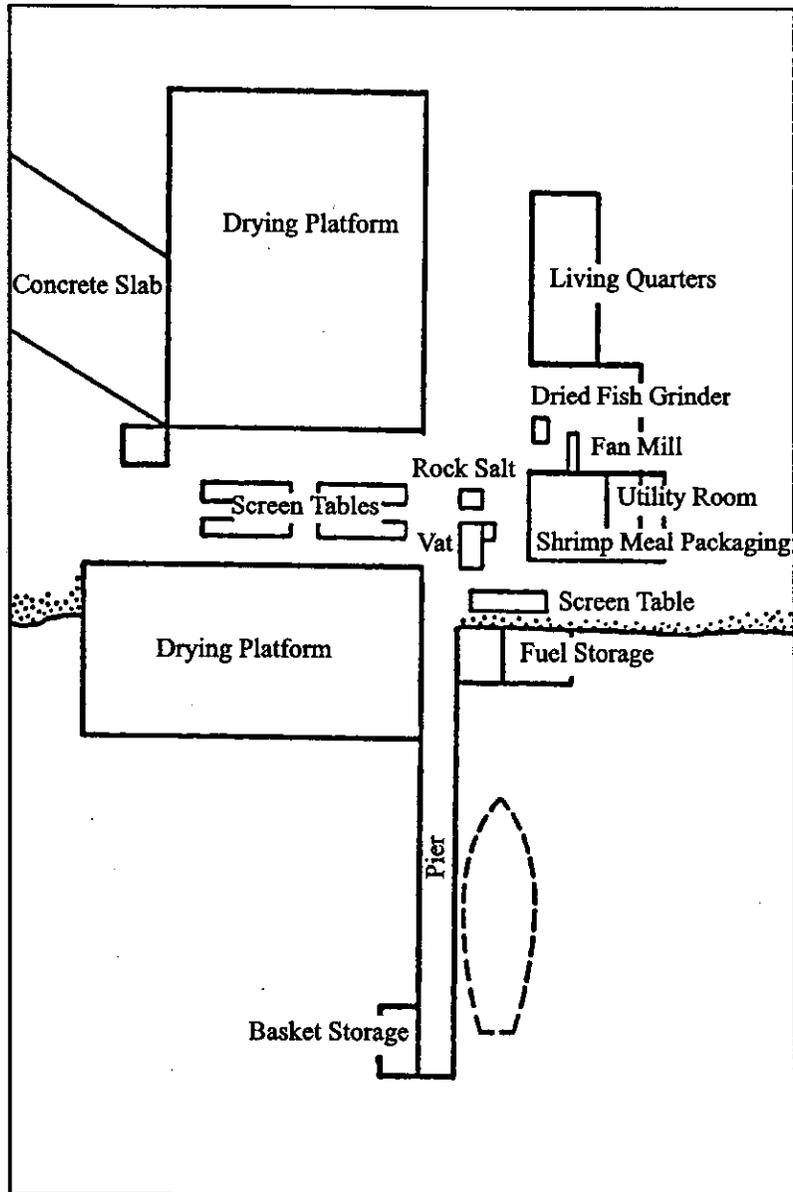
**Figure 15. Sketch Map of Hunters Point Shrimp Company Camp, South of Potrero Point, 1946-1959 (after Bonnot 1932)**

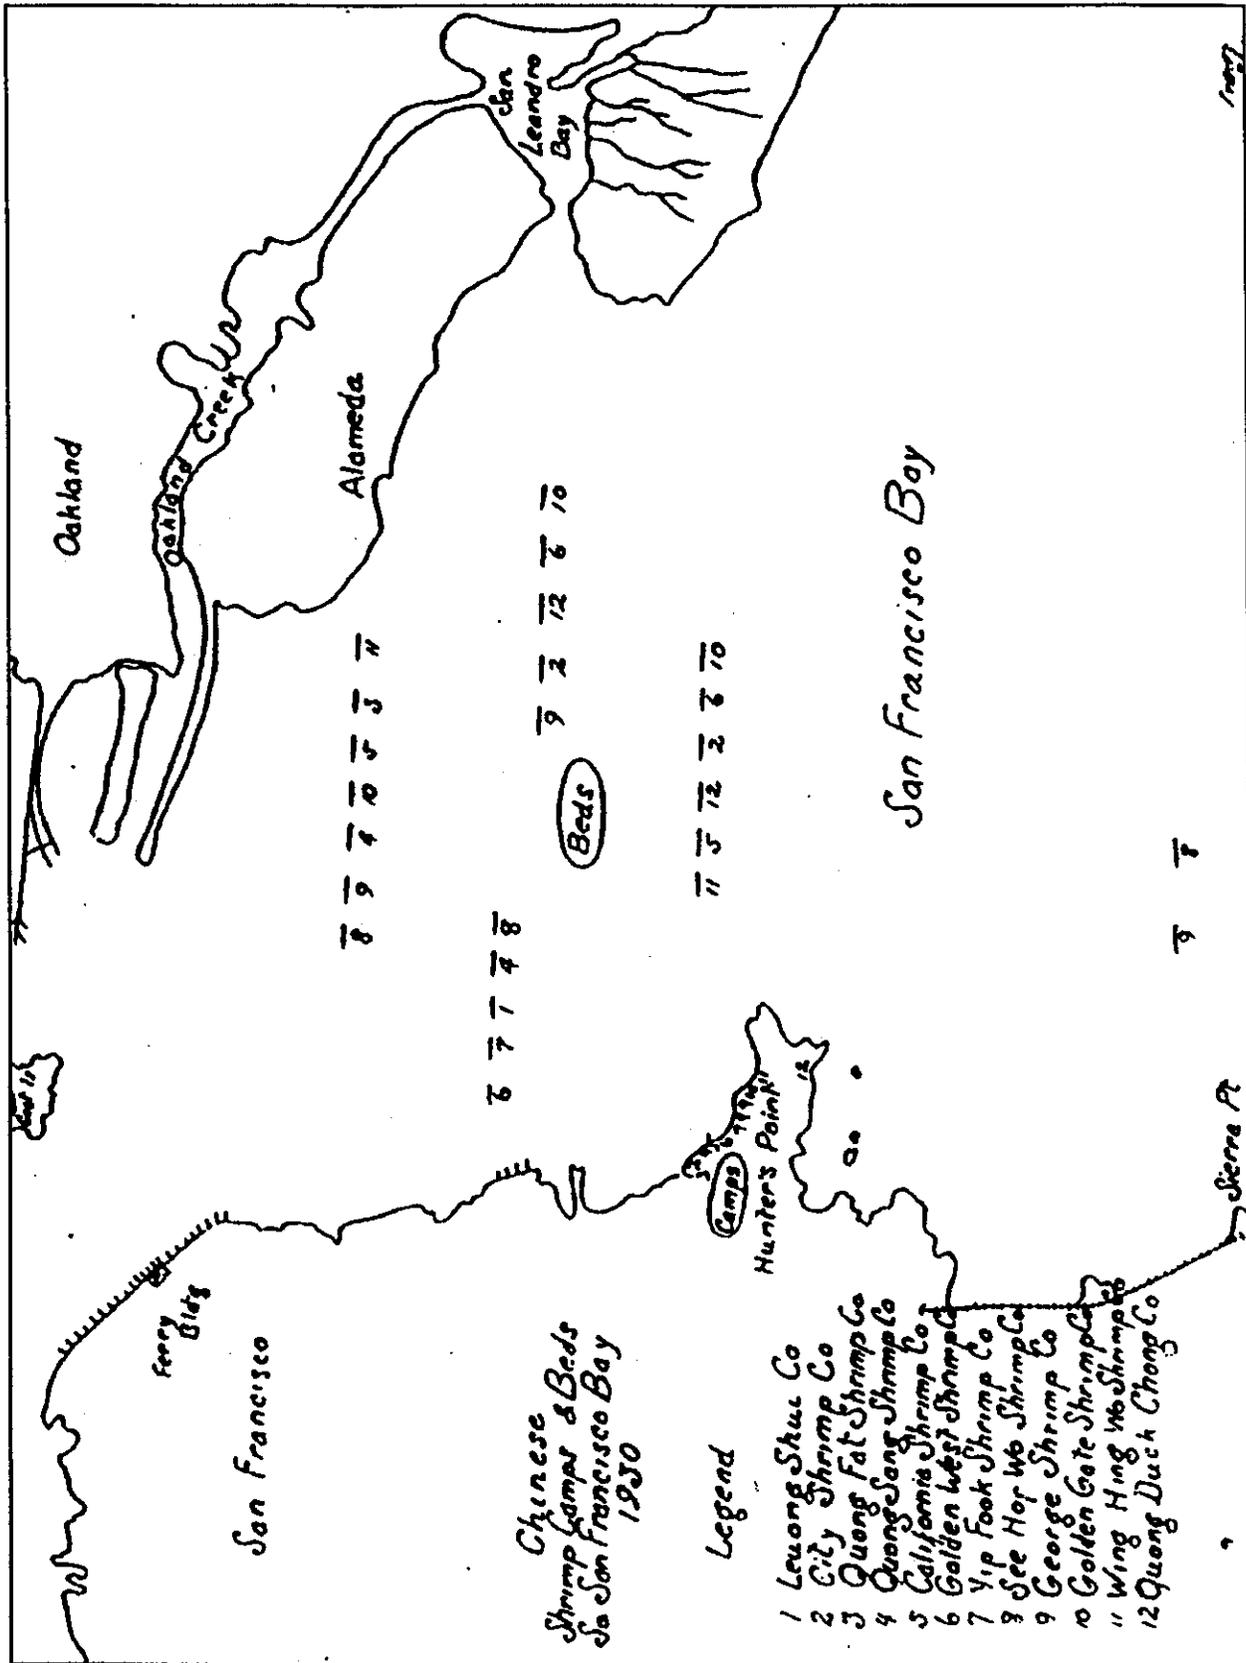
Figure 16. Chinese Shrimp Camps and Beds in South San Francisco Bay (after Bonnot 1932:7)

The beds maintained by each company were held from year to year and were originally laid out on a first-come-first-serve basis (Figure 16) (Bonnot 1932:7). There were unwritten rules concerning the staking of new beds, the most important of which being that "a new bed must be far enough away so it will not cork an old bed" (Bonnot 1932:7). While claim jumping was rare, a controversy between two large companies over the use a particular shrimp bed in 1930 nearly precipitated a tong war (Bonnot 1932:7). While larger shrimp were sold fresh to distributors, the majority were boiled in brine

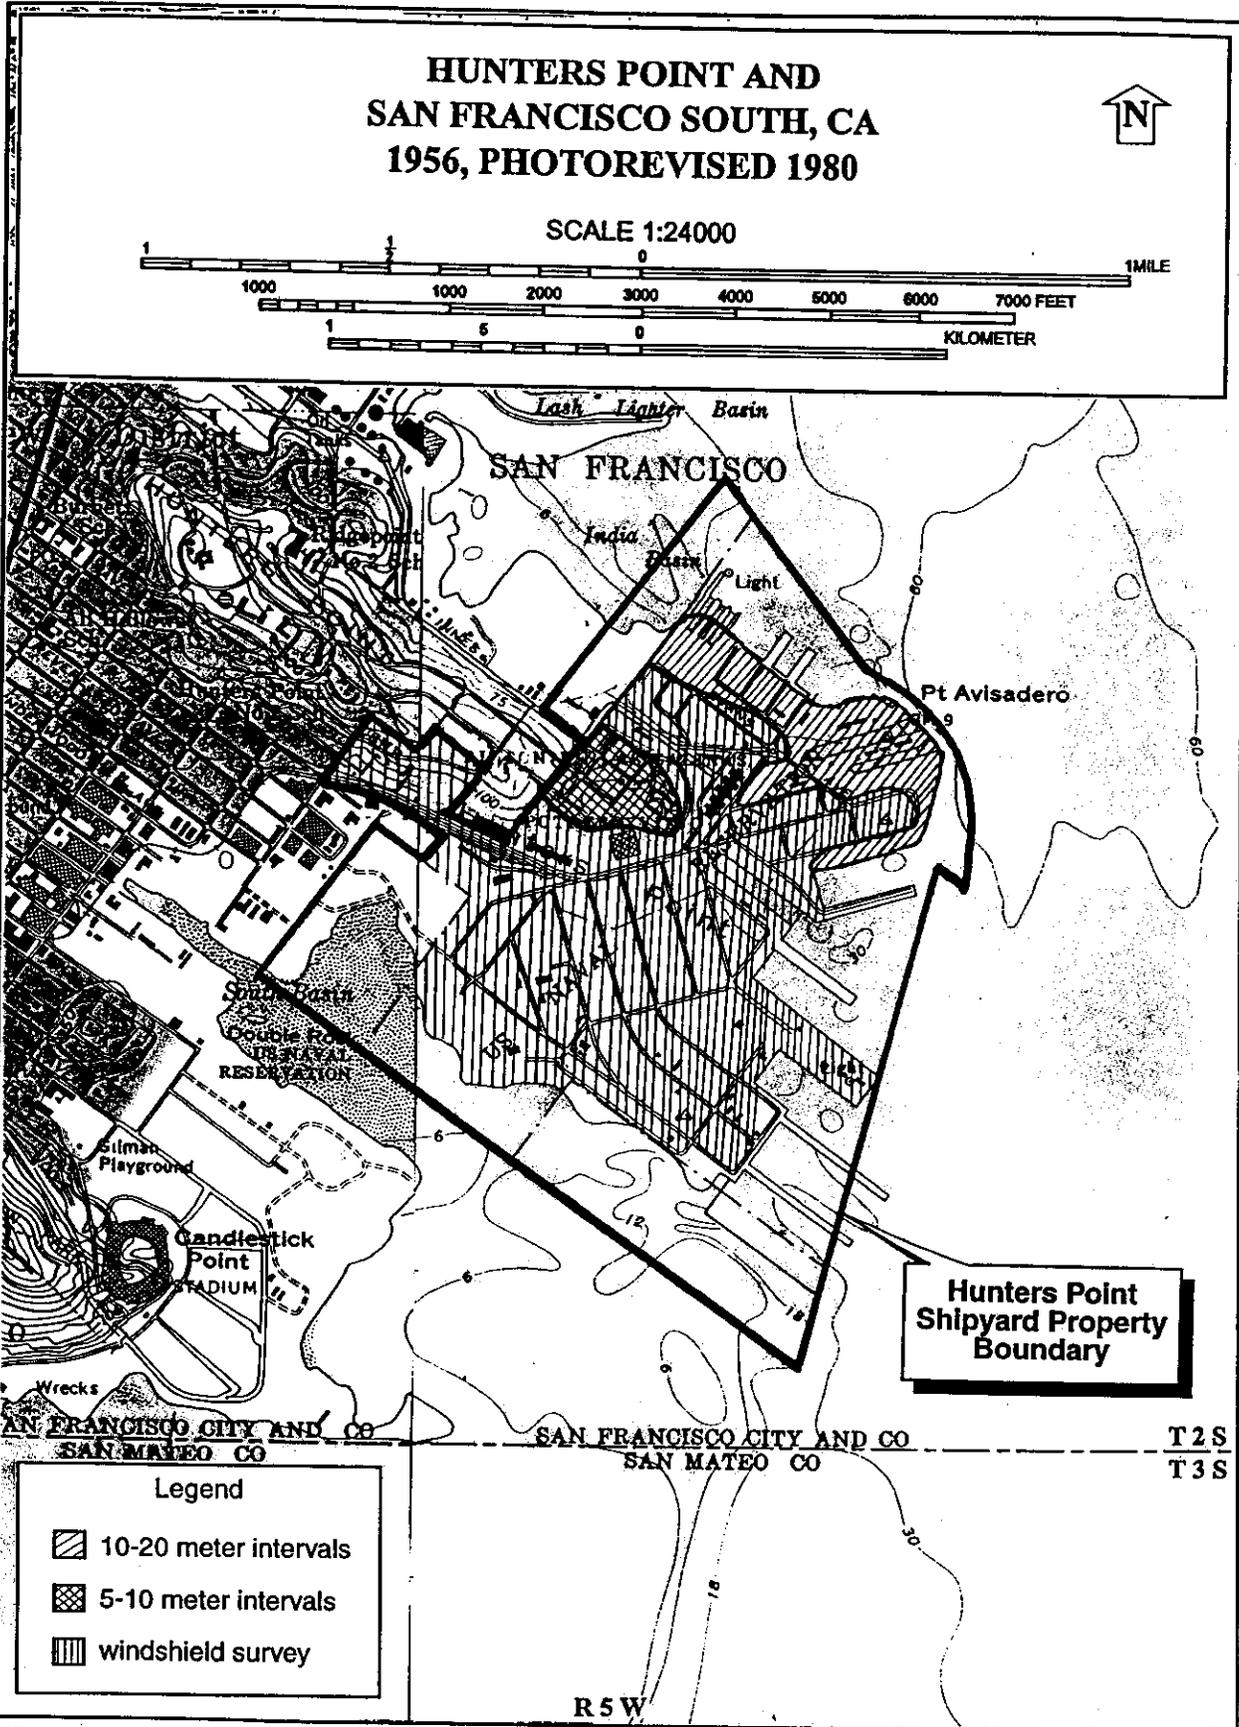
Figure 18. Archaeological Survey Coverage

Once the known areas of archeological sensitivity were identified and plotting was completed, two archeologists conducted a combination pedestrian and windshield survey of the Navy-owned property on Hunters Point. The pedestrian survey involved survey crew members systematically walking the area, wherever feasible, with transects spaced at 10- to 25-meter intervals. Some portions of the base were closed to pedestrian traffic due to presence of hazardous materials. These areas were not examined except from a distance through the fencing. In those areas in which the potential for archeological features appeared to be greater (e.g, remnant hilltop and slope), a more intensive investigation was performed, with transect spacing reduced to 5 meters or less (Figure 18). Wherever possible, subsurface exposures caused by road cuts, cutbank erosion, tree falls, and rodent holes were examined for evidence of buried cultural deposits. No evidence of archeological deposits was found.

The majority of the Hunters Point facility was found to be either paved or covered with large structures, except in the housing area and on the south slope of the remnant hill. Surveyors gave particular attention to the shoreline that surrounds the north, east and southern boundaries. Ground visibility within the landscaped housing portions of Hunters Point on the hill was judged to be poor. As a result of the extensive cut and fill operations that have taken place over the years, it is estimated that only five percent of Hunters Point original ground surfaces are presently visible.

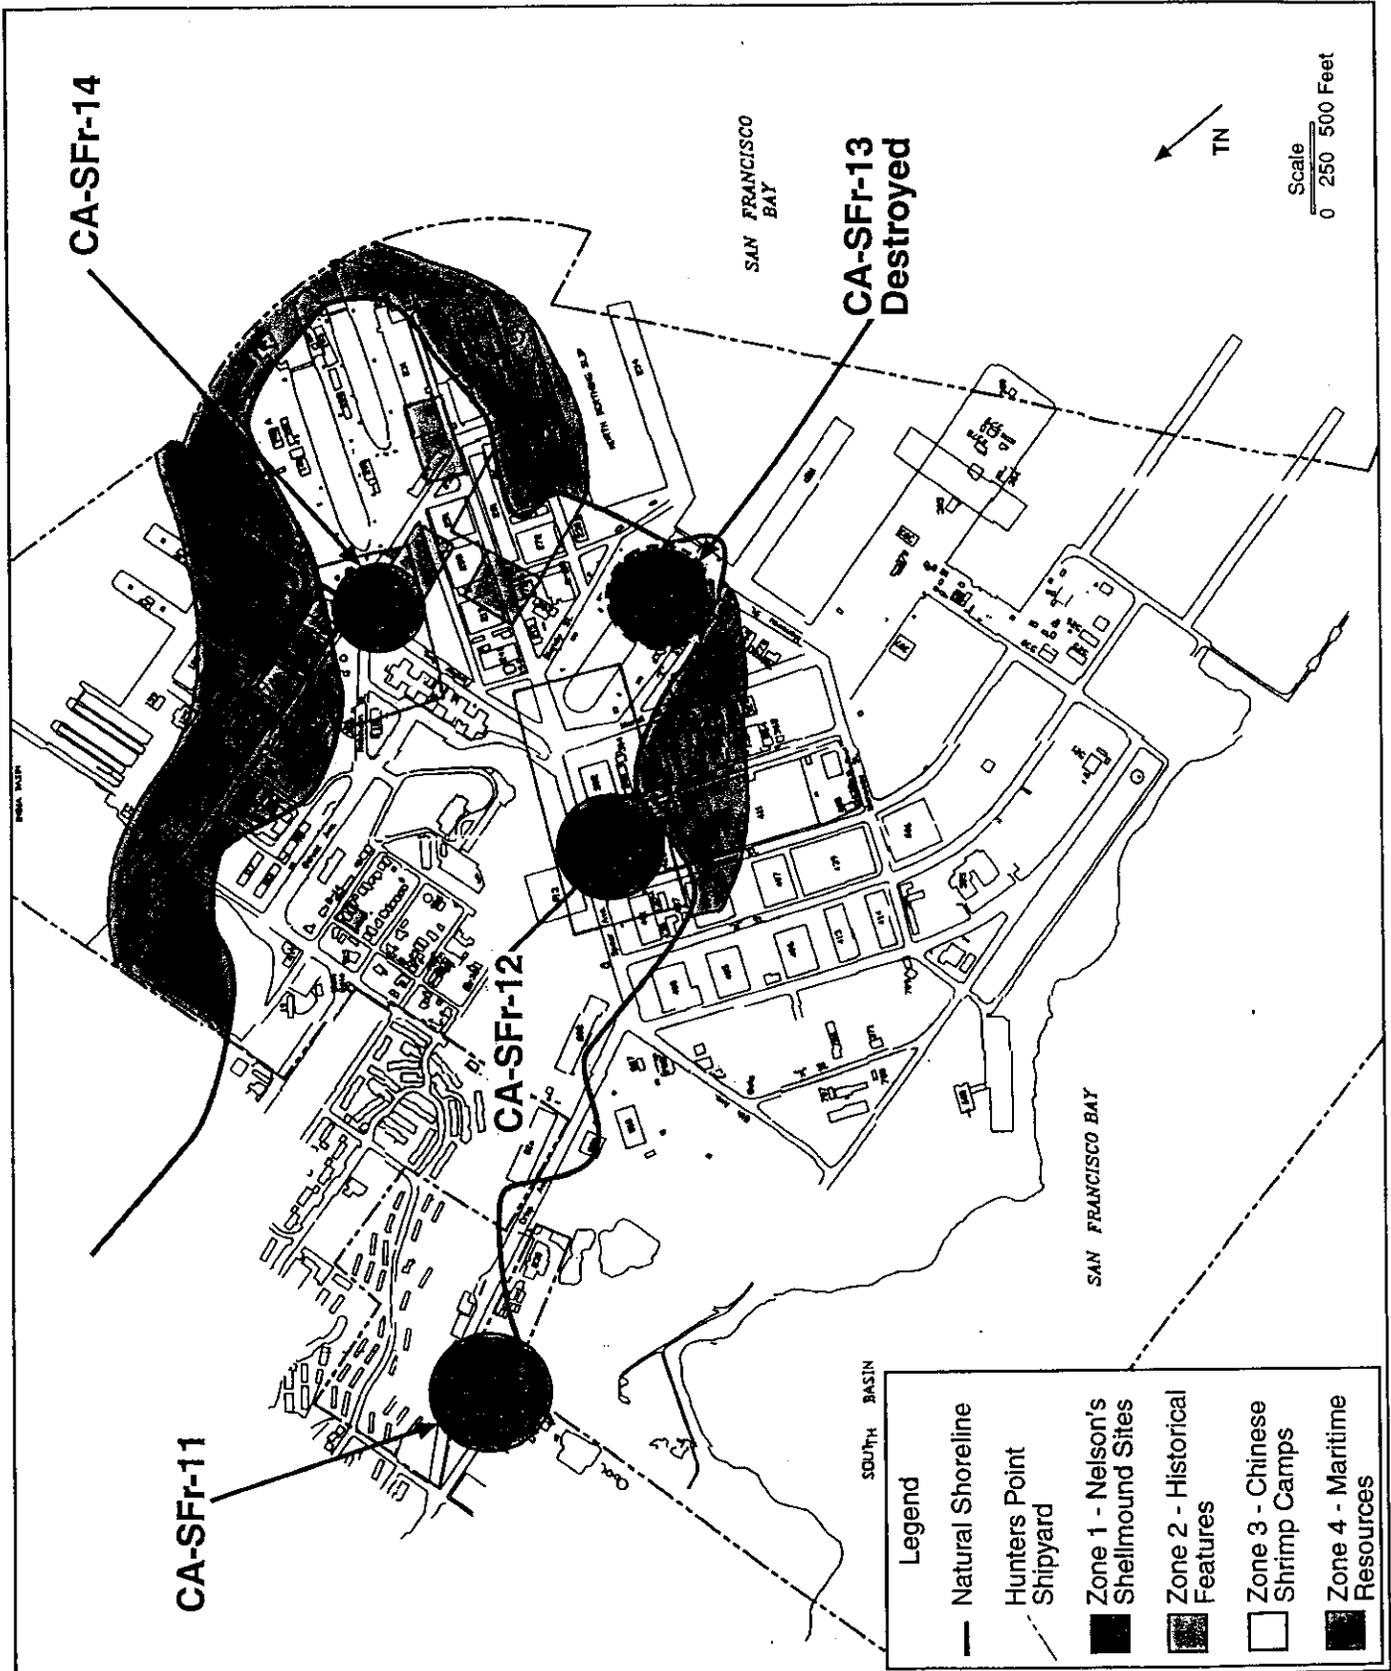
Figure 21. Archeologically Sensitive Zones at Hunters Point

Included in Zone 2 are the locations of historic-era structures based on an analysis of historical maps and photographs dating from 1852 to 1929, including Sanborn Fire Insurance maps drawn in the early 1900s. Although foundation remnants

Zone 3 is more specific in its research focus and time periods and includes the probable locations of Chinese shrimp camps that date from the early to mid-1870s to early 1940s. As noted within the historical context section, a number of Chinese shrimp camps were reportedly located at Hunters Point, however, an examination of historical maps and archival data indicates that only five were present within the present day boundaries of HPS. A map prepared for the *Chinese Historical Society of American Syllabus* by Robert Nash indicates that, in 1910, the Fook On Lung Company had one camp along the north shoreline of Hunters Point, north of Hudson Avenue, near Alvord Street (close to the present day intersection of Robinson and Lockwood Avenue) and another camp along the same shoreline but further to the west. The Quong Lee Chong Company had two camps along the south shoreline of Hunters Point, south of Innes Avenue, near Alvord Street (south of present day Spear Avenue between N and Blandy streets (Chinn 1973:39). Apparently by the 1930s, the only camps remaining at HPS were those belonging to the Quong Lee Chong Company, although photographs from the mid- to late-1930s show an unnamed shrimp camp situated southwest of Dry Dock No. 2 along the shoreline (between present day Spear and Nimitz avenues).

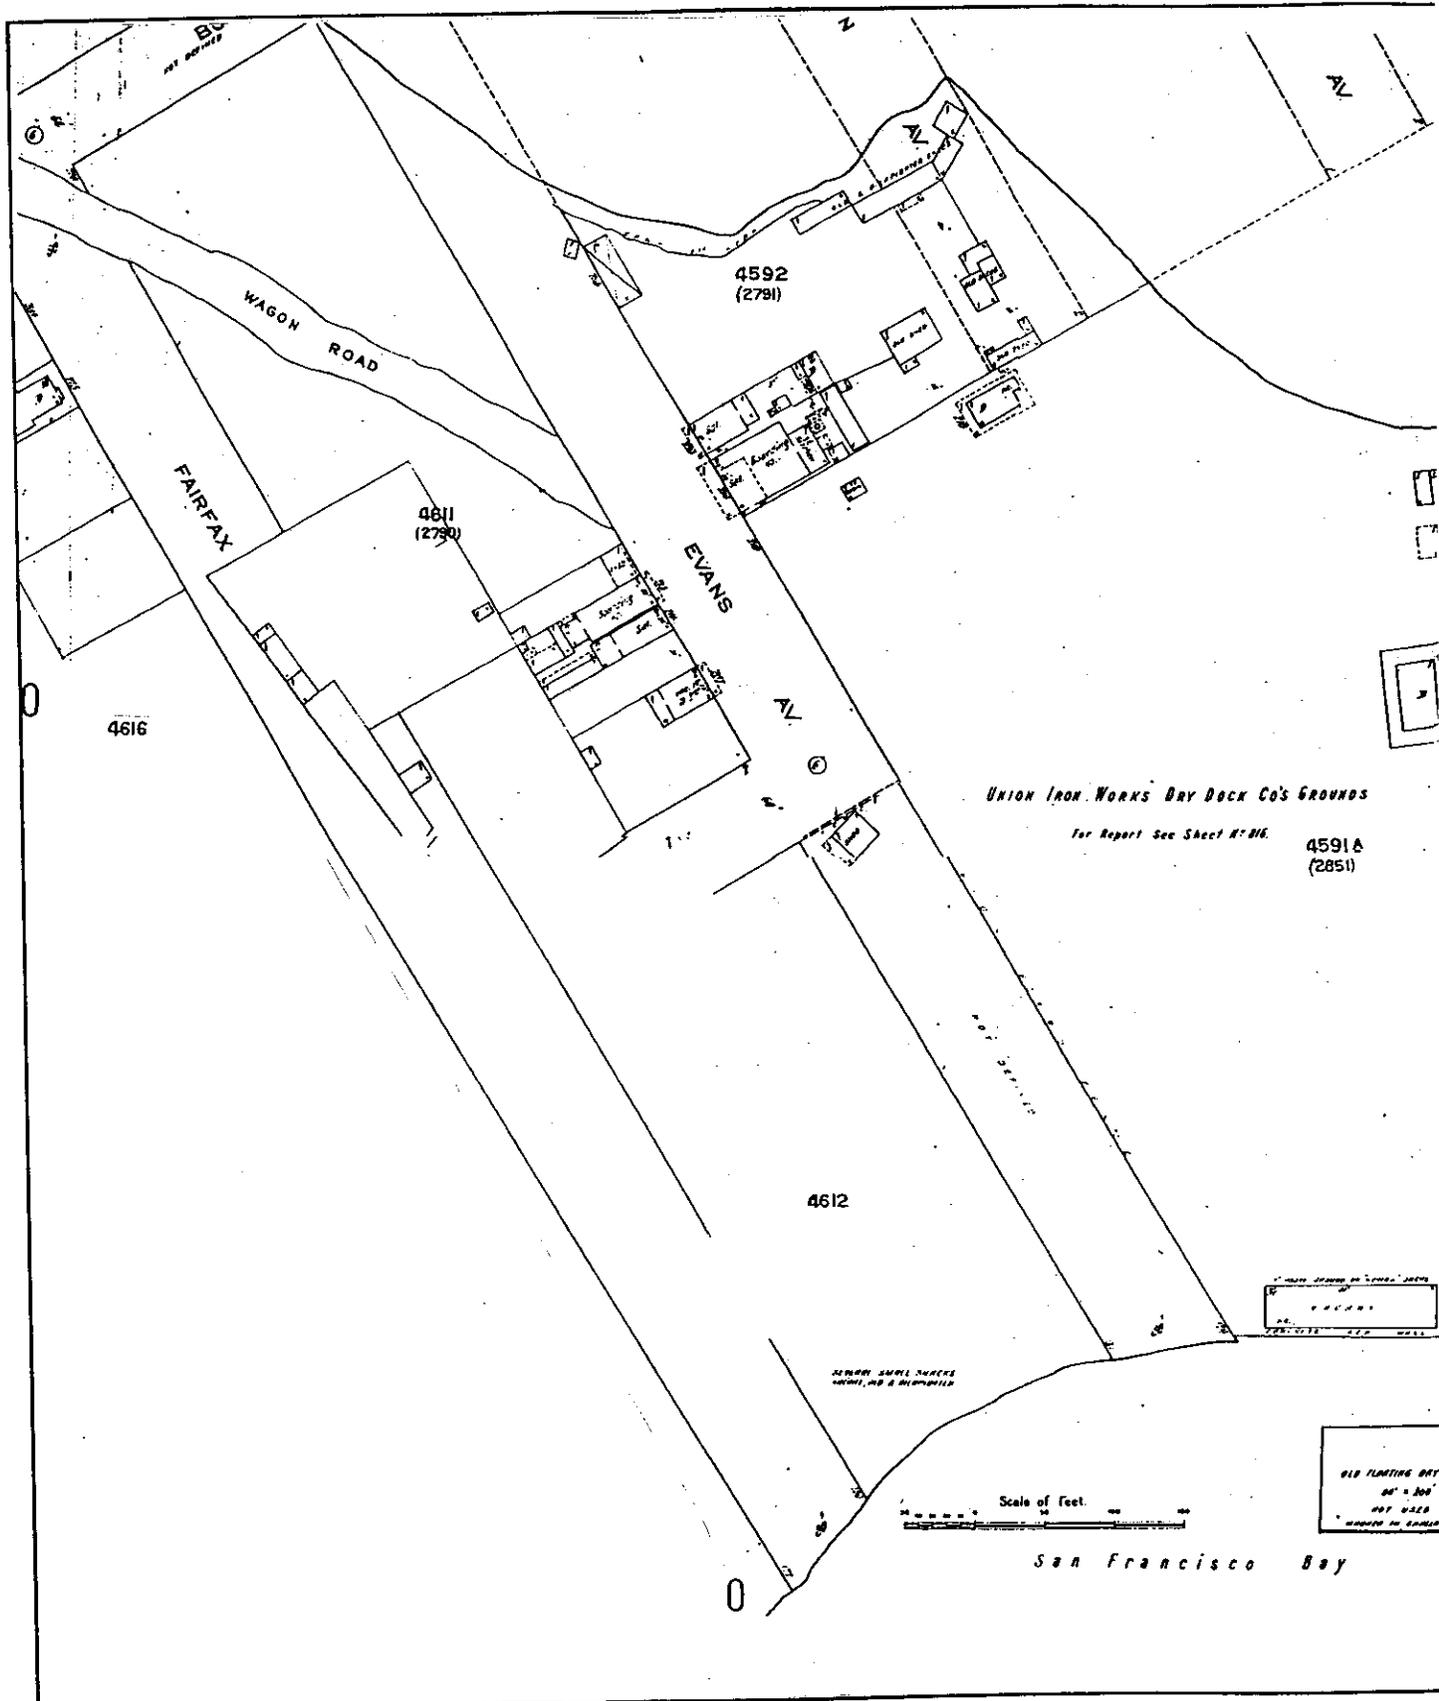
**Figure A-6. Union Iron Works Dry Dock Company circa 1913**  
 (after Sanborn Fire Insurance Map 1913-1915)

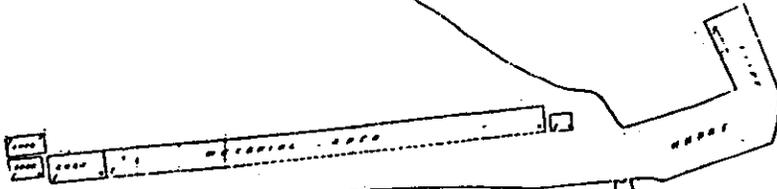
Figure 5. Dry Docks Nos. 1 and 2

10 DRY DOCK TO BE CONSTRUCTED HERE

4591A  
(2851) DRY DOCK NO. 1  
100' LONG, 40' DEEP  
ENTIRE DRY DOCK - CONCRETE LINING

Wharf Approaches, wooden superstructure with cross-tied piles. Bilge ways of New Dock flush with surface of floor to facilitate trucking. Pumping Plant, serves both docks and consists of 1275 H.P. Boiler capacity Babcock & Wilcox Water-tube 3 Engines 24x48 C.P. Allis Corliss, 350 H.P. each and 3-38" Centrifugal Pumps with closed runners and external vanes designed by the Chief Engineer, built by M.T. Garrard & Co. S.F., driven by endless rope, Valves in suction tunnel 36" in dia. are worked by a hydraulic cylinder.

By 1900, the California Dry Dock Company had sold to the San Francisco Dry Dock Company. The new owners hired engineer Howard C. Holms to design a new larger dry dock next to the older one (Figures 4 and 5). A new pump house was also constructed to operate both docks. At completion in 1903, Dry Dock No. 2 was 750 feet long and the largest at that time on the West Coast. Its superior size and the fine reputation of Hunters Point boatwrights made the new facility in great demand (Bamburg 1988:7-8).

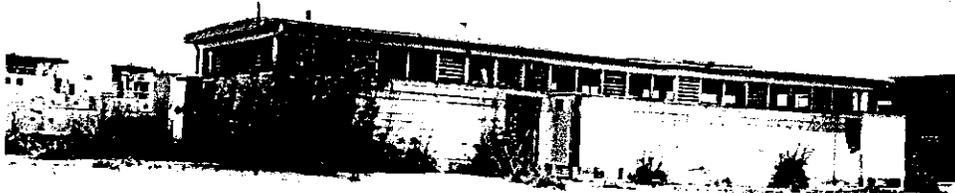
Photograph 2. Building 281

A few large shipyard buildings were constructed at Hunters Point during the early 1970s, just before the Navy left the facility. The buildings are pre-engineered, metal framed, metal siding shops, all built in the same general manner. One example is Building 439, shown in **Photograph 1**. Buildings 228, 281, and 282 are also examples; Building 281 is shown in **Photograph 2**.

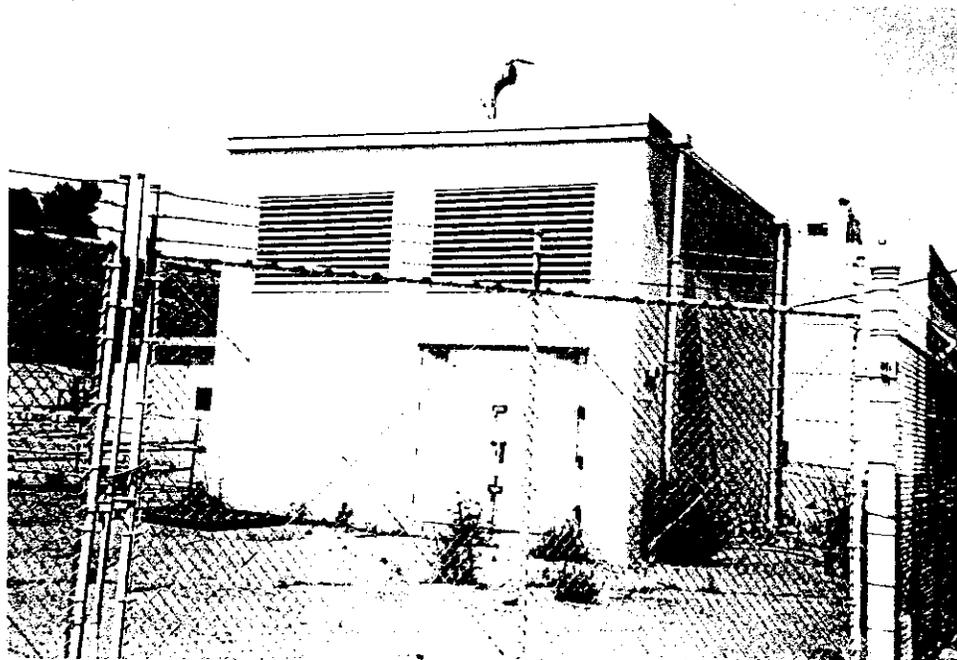
**Photograph 3. Building 370**

Building 370, is a toilet building constructed in 1953. It is virtually indistinguishable from the many toilets built in the Shipyard during World War II; it is shown in **Photograph 3**. Pumphouses and substation enclosures were built during the immediate post-war era, as they had been built during World War II. These generally follow the World War II designs. Building 819 is a 1957 substation, shown in **Photograph 4**; it is identical to World War II-era substation enclosures. Building 523, shown in **Photograph 5**, is unusual only in that the walls are brick

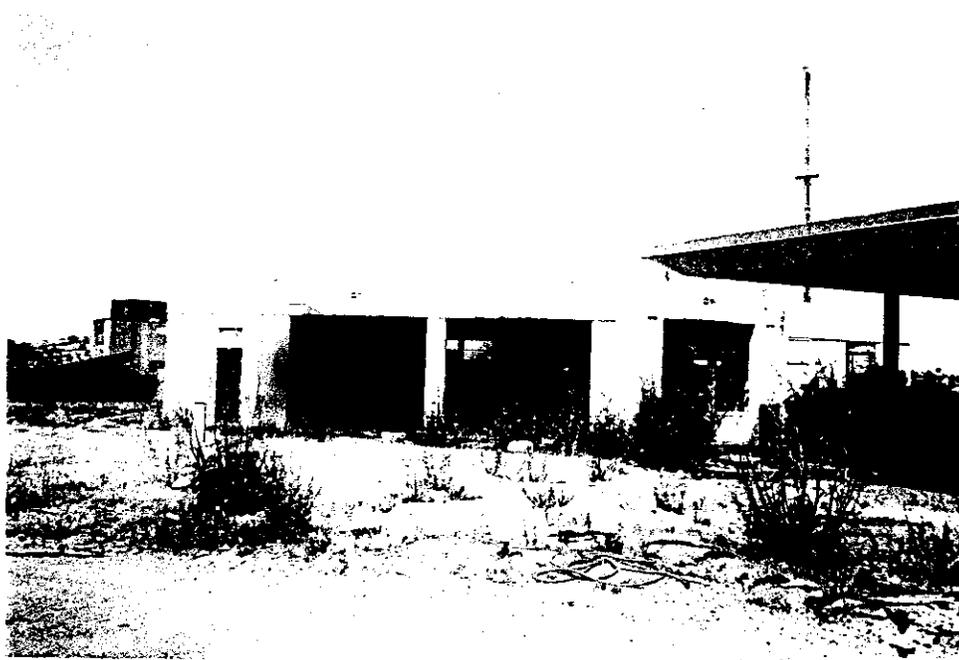
**Photograph 5. Building 523**

rather than concrete; it was built in 1948. A few of the early Cold War buildings are unlike their World War II counterparts. Building 709 is a reinforced concrete gasoline service station, built in 1952; its World War II counterpart would have been built of wood. It is shown in **Photograph 6**.

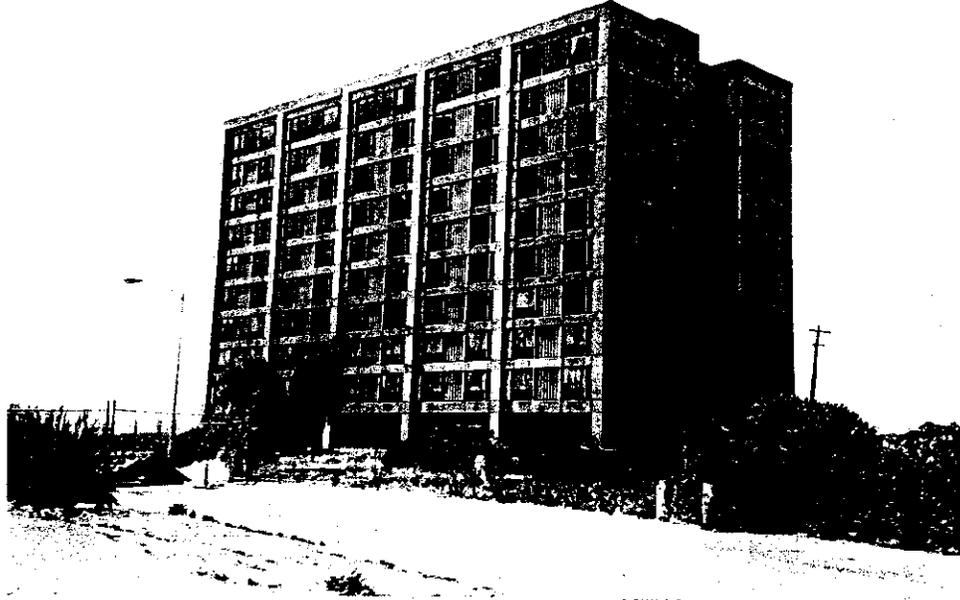
**Photograph 10. Building 830**

The USNRD Laboratory occupied only a few buildings at the southern extreme of the Hunters Point Shipyard. It appears that the laboratory function occupied a group of buildings in the 800 Series, including Building 815 (Radiological Laboratory), Building 820 (Navy Radiation Laboratory); and Building 830 (a Navy Biological Laboratory).<sup>6</sup> Building 815 is a concrete laboratory, built in about 1970, shown in **Photograph 8**. Building 820 is a reinforced concrete building, constructed in about 1965; it is shown in **Photograph 9**. Building 830 is a pre-engineered large metal shed, built in about 1970; it is shown in **Photograph 10**.
