**Historic Context
and
Inventory and Evaluation of
Buildings and Structures
HUNTERS POINT SHIPYARD
San Francisco, California**

Engineering Field Activity, West
Naval Facilities Engineering Command
900 Commodore Drive
San Bruno, California 94066-5006

JRP Historical Consulting Services
1477 Drew Avenue, Suite 105
Davis, California 95616

September 1997

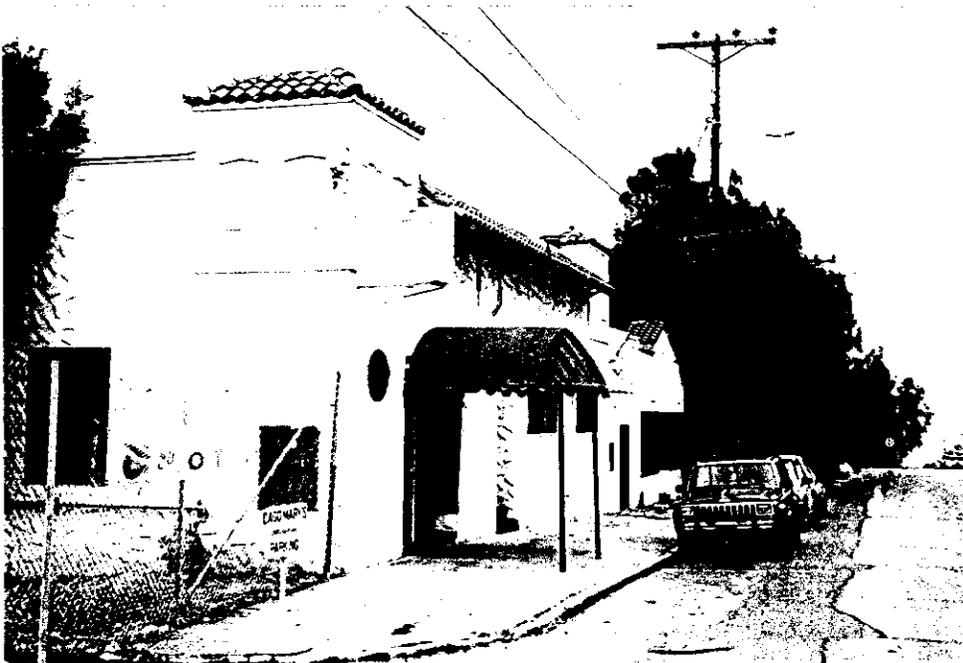
*P3a. Description: (Describe resource and its major elements. Include design, materials, condition, alterations, size, setting, and boundaries.)
Building 916 is a rambling wood frame restaurant building. The ca. 1930 building pre-dates Navy acquisition of the area and therefore pre-dates the massive earth-moving that transformed the geography of much of Hunters Point. The building was built to conform to the hillside, which slopes to the north of Donahue Street; it is one-story at the street level and two-story at the rear. (see continuation sheet)

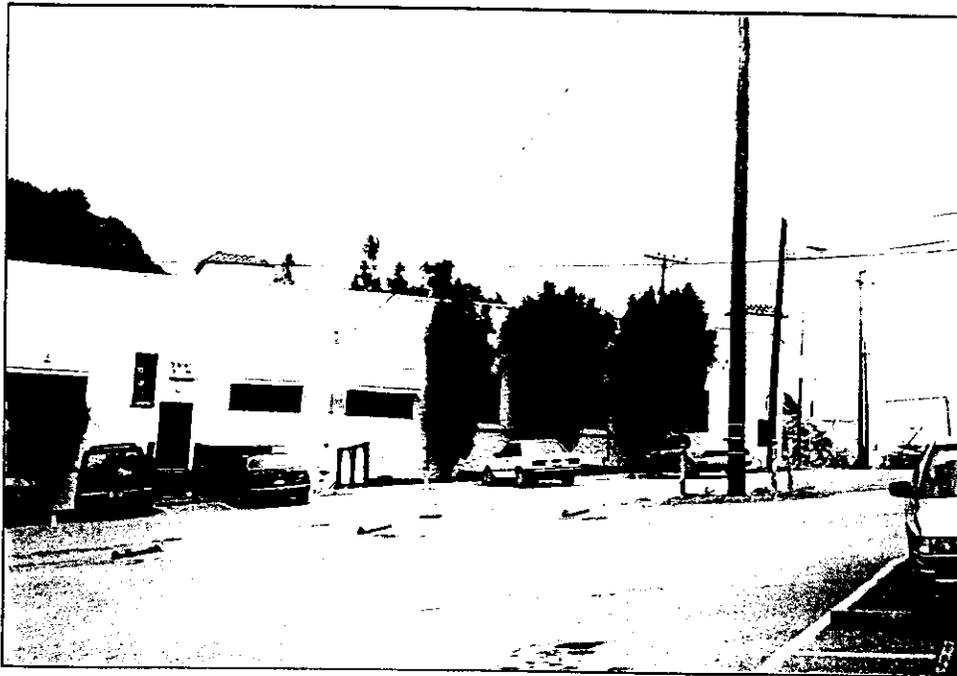
Photograph 2

The eastern side elevation steps down the natural hillside. This elevation is shown in Photograph 2. This is a plain elevation by comparison with the facade. As noted, the textured stucco extends to this elevation. There is also a false tower about midpoint along this elevation, as well as the corner tower that is visible from the facade. Otherwise, the side elevation is dominated by a band of fixed sash, which light the dining room inside.

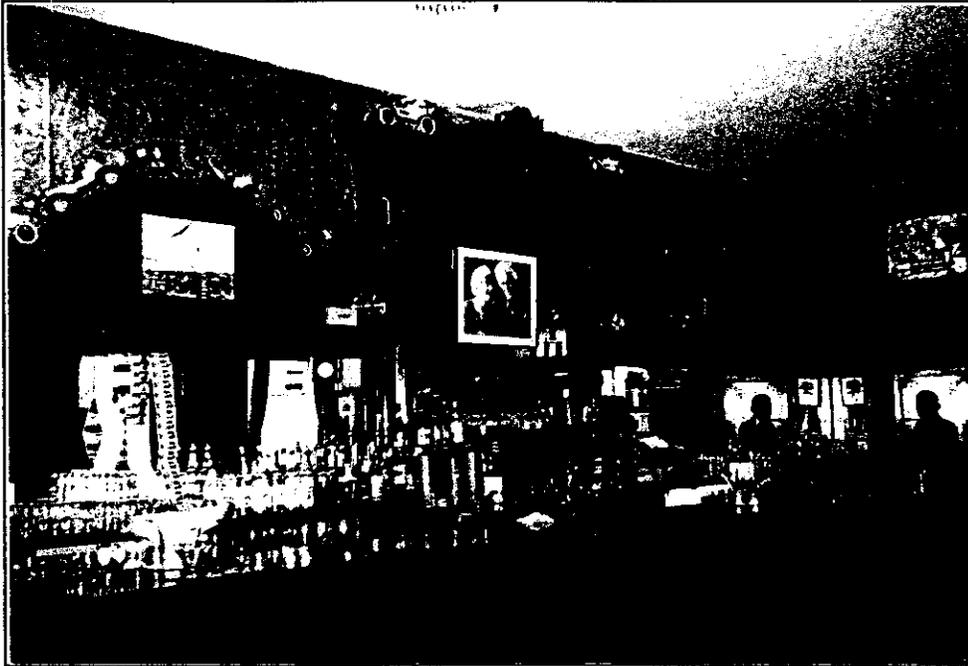
Photograph 3

The interior of the Dago Mary restaurant includes three major rooms: the bar at the front, and two large dining rooms. The bar and dining rooms are filled with lavish woodworking. The interior of the bar is shown in Photograph 3; Photograph 4 is a detailed view of one of the window surrounds. The ornately carved and sawn woodworking is coordinated throughout; as discussed under "Significance," this millwork allegedly came from the Flood Mansion in Menlo Park. The woodwork is said to have been installed when the restaurant first opened. The structure of the building supports that contention. The windows, for example, were built to conform with the shapes of the woodwork. Similarly, the room dividers between the two areas of the dining room are built to conform to the shape of the woodwork. A fireplace at the rear fits exactly with the mantle. In the bar area, however, the imported woodworking appears not to have fit precisely, leaving some awkward joints.

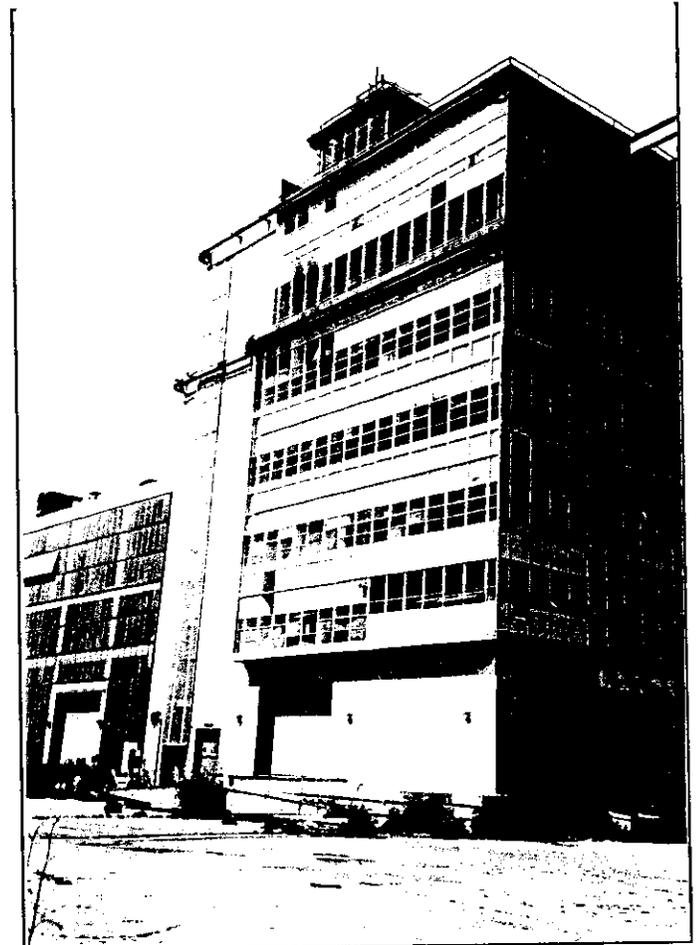
Photograph 3

Building 253 is a concrete frame curtain wall industrial building. It includes two distinct segments. The taller segment is the equivalent of six stories tall, the smaller three stories. Building 211 joins Building 253 at the rear of 253, near the juncture between the three and six story elements. The six story element of Building 253 is built around a reinforced concrete frame with bands of glazing at each level. It includes a freight elevator near the northwest corner and a gantry at the sixth story for external hoisting. The smaller element is almost entirely glazed, with only narrow concrete frame members visible from the exterior. The two elements are shown in **Photograph 3**; the main elevation of the six-story element is shown in **Photograph 4**.

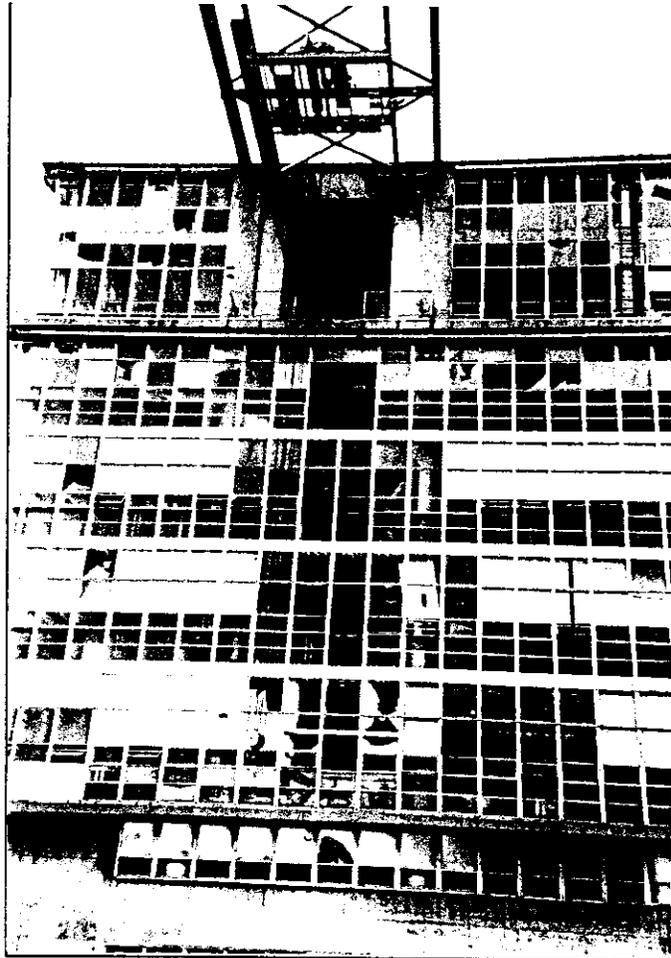
Photograph 4

Building 253 has a diminished integrity owing chiefly to the loss of a great deal of the glazing. The loss of glazing, shown most clearly in **Photograph 4**, appears to be attributable to vandalism and perhaps to wind damage as well. The integrity of Building 211 was affected adversely through installation of asbestos siding and through construction of Building 253. Taken as a single building, the 253/211 structure retains a fair to poor degree of integrity.

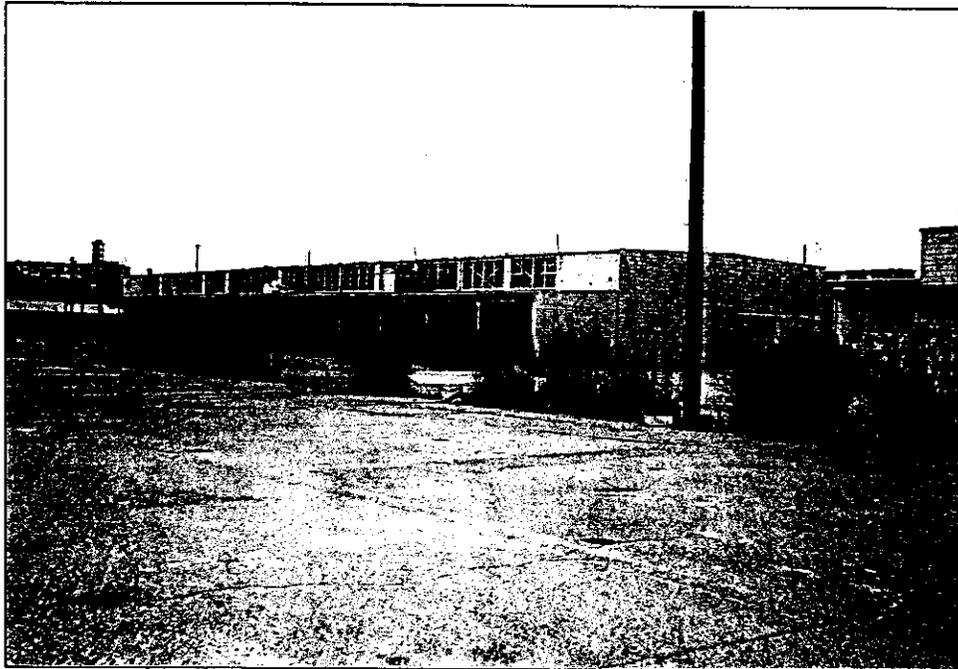
Building 130

This variation on that form includes a shallow (almost flat) gabled roof and glazed monitors with open shed wings at either side. The buildings also include wooden sliding industrial doors at either end.

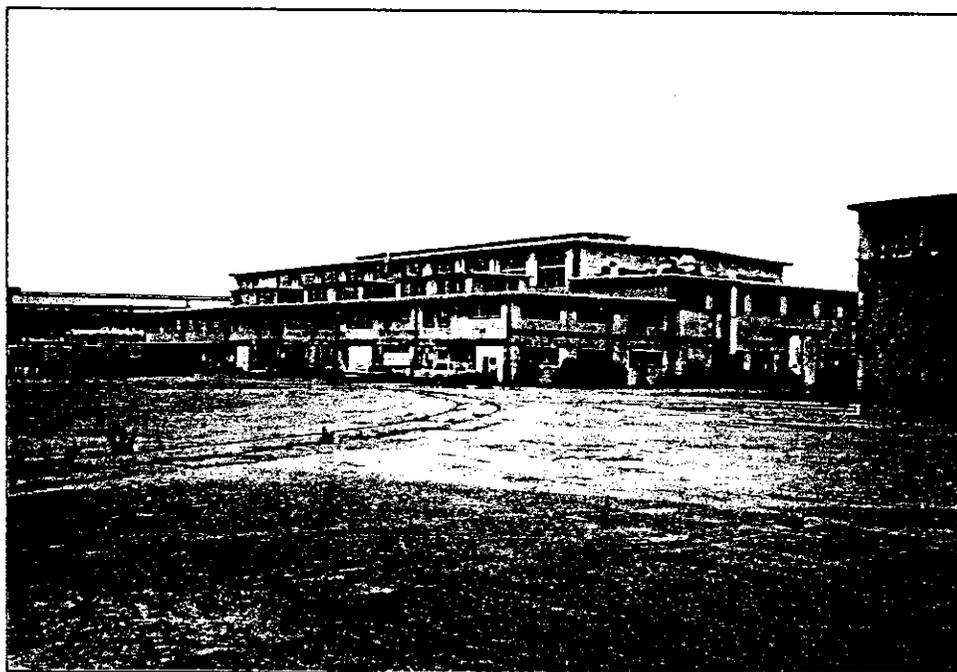
Building 134

The buildings are characterized by a rambling plan, with a large three-story area to one side, joined by a T-shaped second story segment and a rectangular area at the first story. The buildings appear to retain a high degree of integrity.

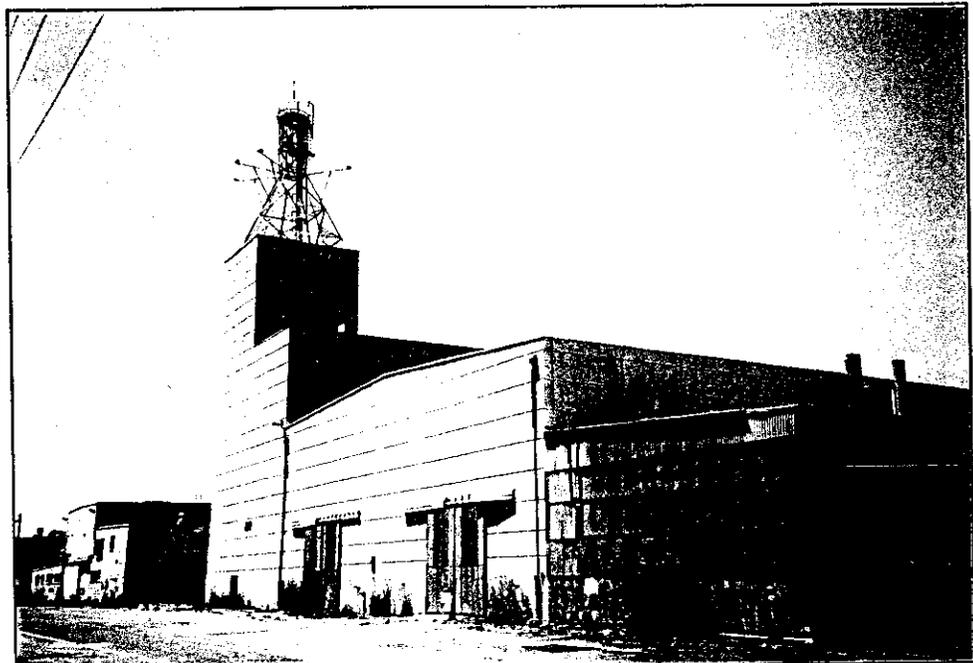
Building 258 has received the greatest amount of modification since it was built in 1943. Most noticeable is the multiple-story addition to the west side of the building. The main portion of this addition is approximately six stories with a row of nine-pane awning style windows along the second story. Each west side corner has been raised to approximately nine stories with an antenna cluster sitting atop the southwest corner. The exterior of Building 258 is now covered with scored concrete.

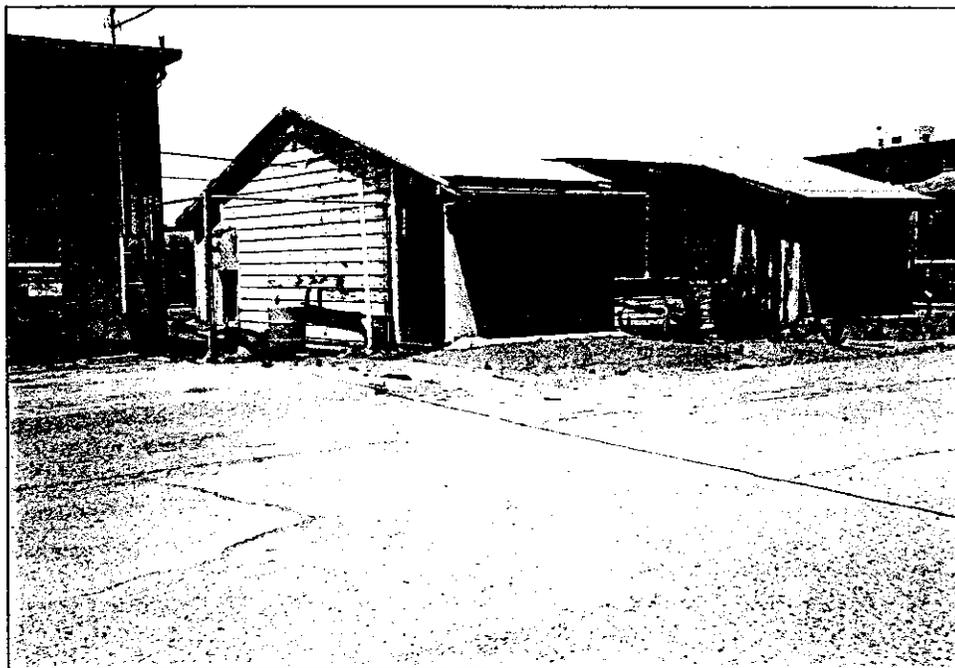
Photograph 6. Building 424

Building 424 is a small office and storage building in the south shipyard area. It is wood frame with V-groove rustic siding. It includes some of its original one-over-one double-hung wooden sash. The principal entries, at the left and right of the facade, have been covered in plywood. It is shown in **Photograph 6**.
