NAVAL NUCLEAR POWER UNIT
FORT BELVOIR, VIRGINIA

Date: 11 September 1973
File: 3220.24k
RASO Report No.: 81

RADIOLOGICAL AFFAIRS SUPPORT OFFICE REPORT OF TECHNICAL ASSISTANCE VISIT TO HUNTERS POINT NAVAL SHIPYARD, SAN FRANCISCO, CALIFORNIA, 23 - 25 JULY 1973

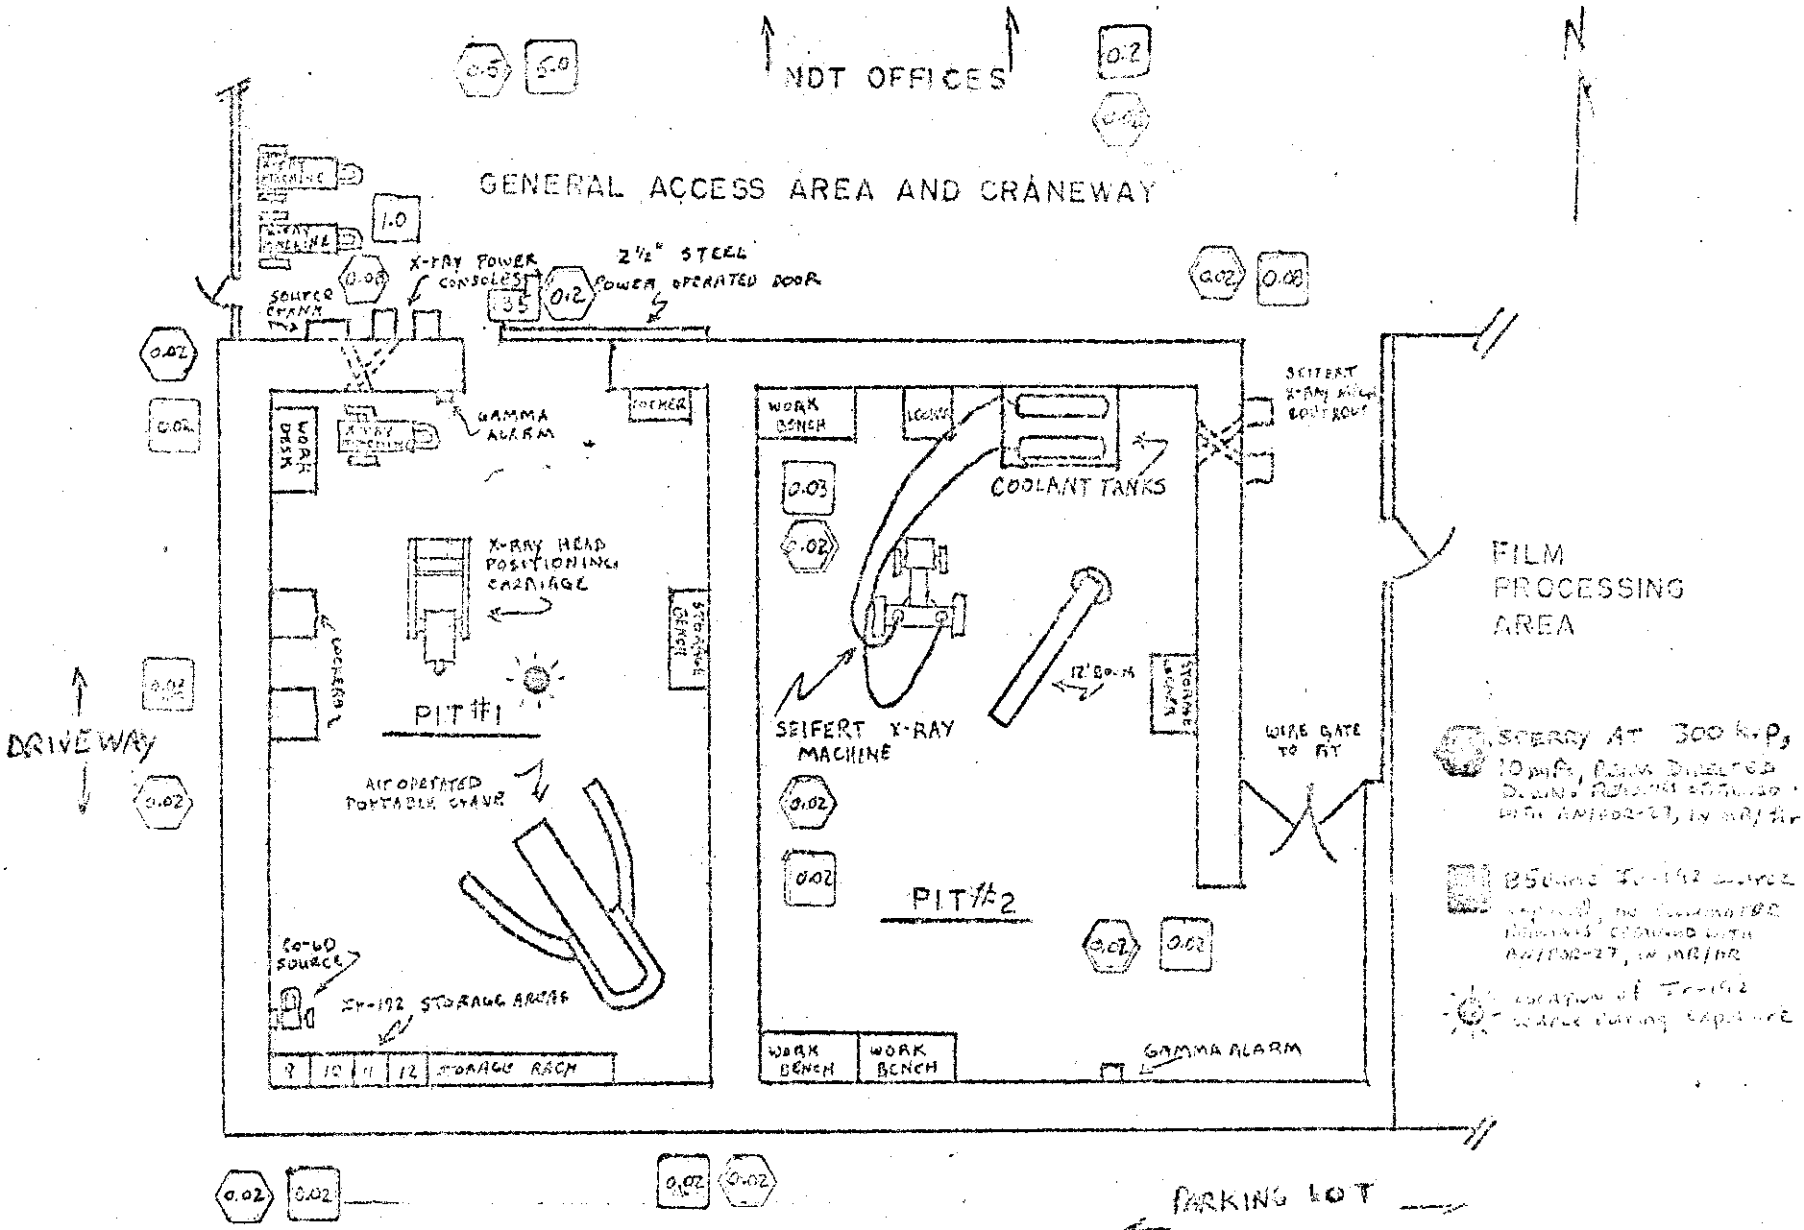
BLDG 113A

1. Facility description. Isotopes and x-ray machines were used in stationary and field locations to obtain radiographs. The stationary facilities were established in Building 113A. The building had two 20' by 28' concrete exposure rooms designated pit #1 and pit #2 as shown in Figure 1, Appendix A.

a. Surveys performed by radiographers during operations were not being recorded.

b. Neither x-ray controls nor power sources were locked when not in use.

1. That surveys be recorded during all portable x-ray radiography operations. Survey records should contain a drawing of the radiography area and include such data as radiation levels, beam orientation, machine parameters, and the location of the operations. This data, along with any previously recorded data should be made available to the RSO.

2. That controls of the power to the x-ray units be locked when not in use.

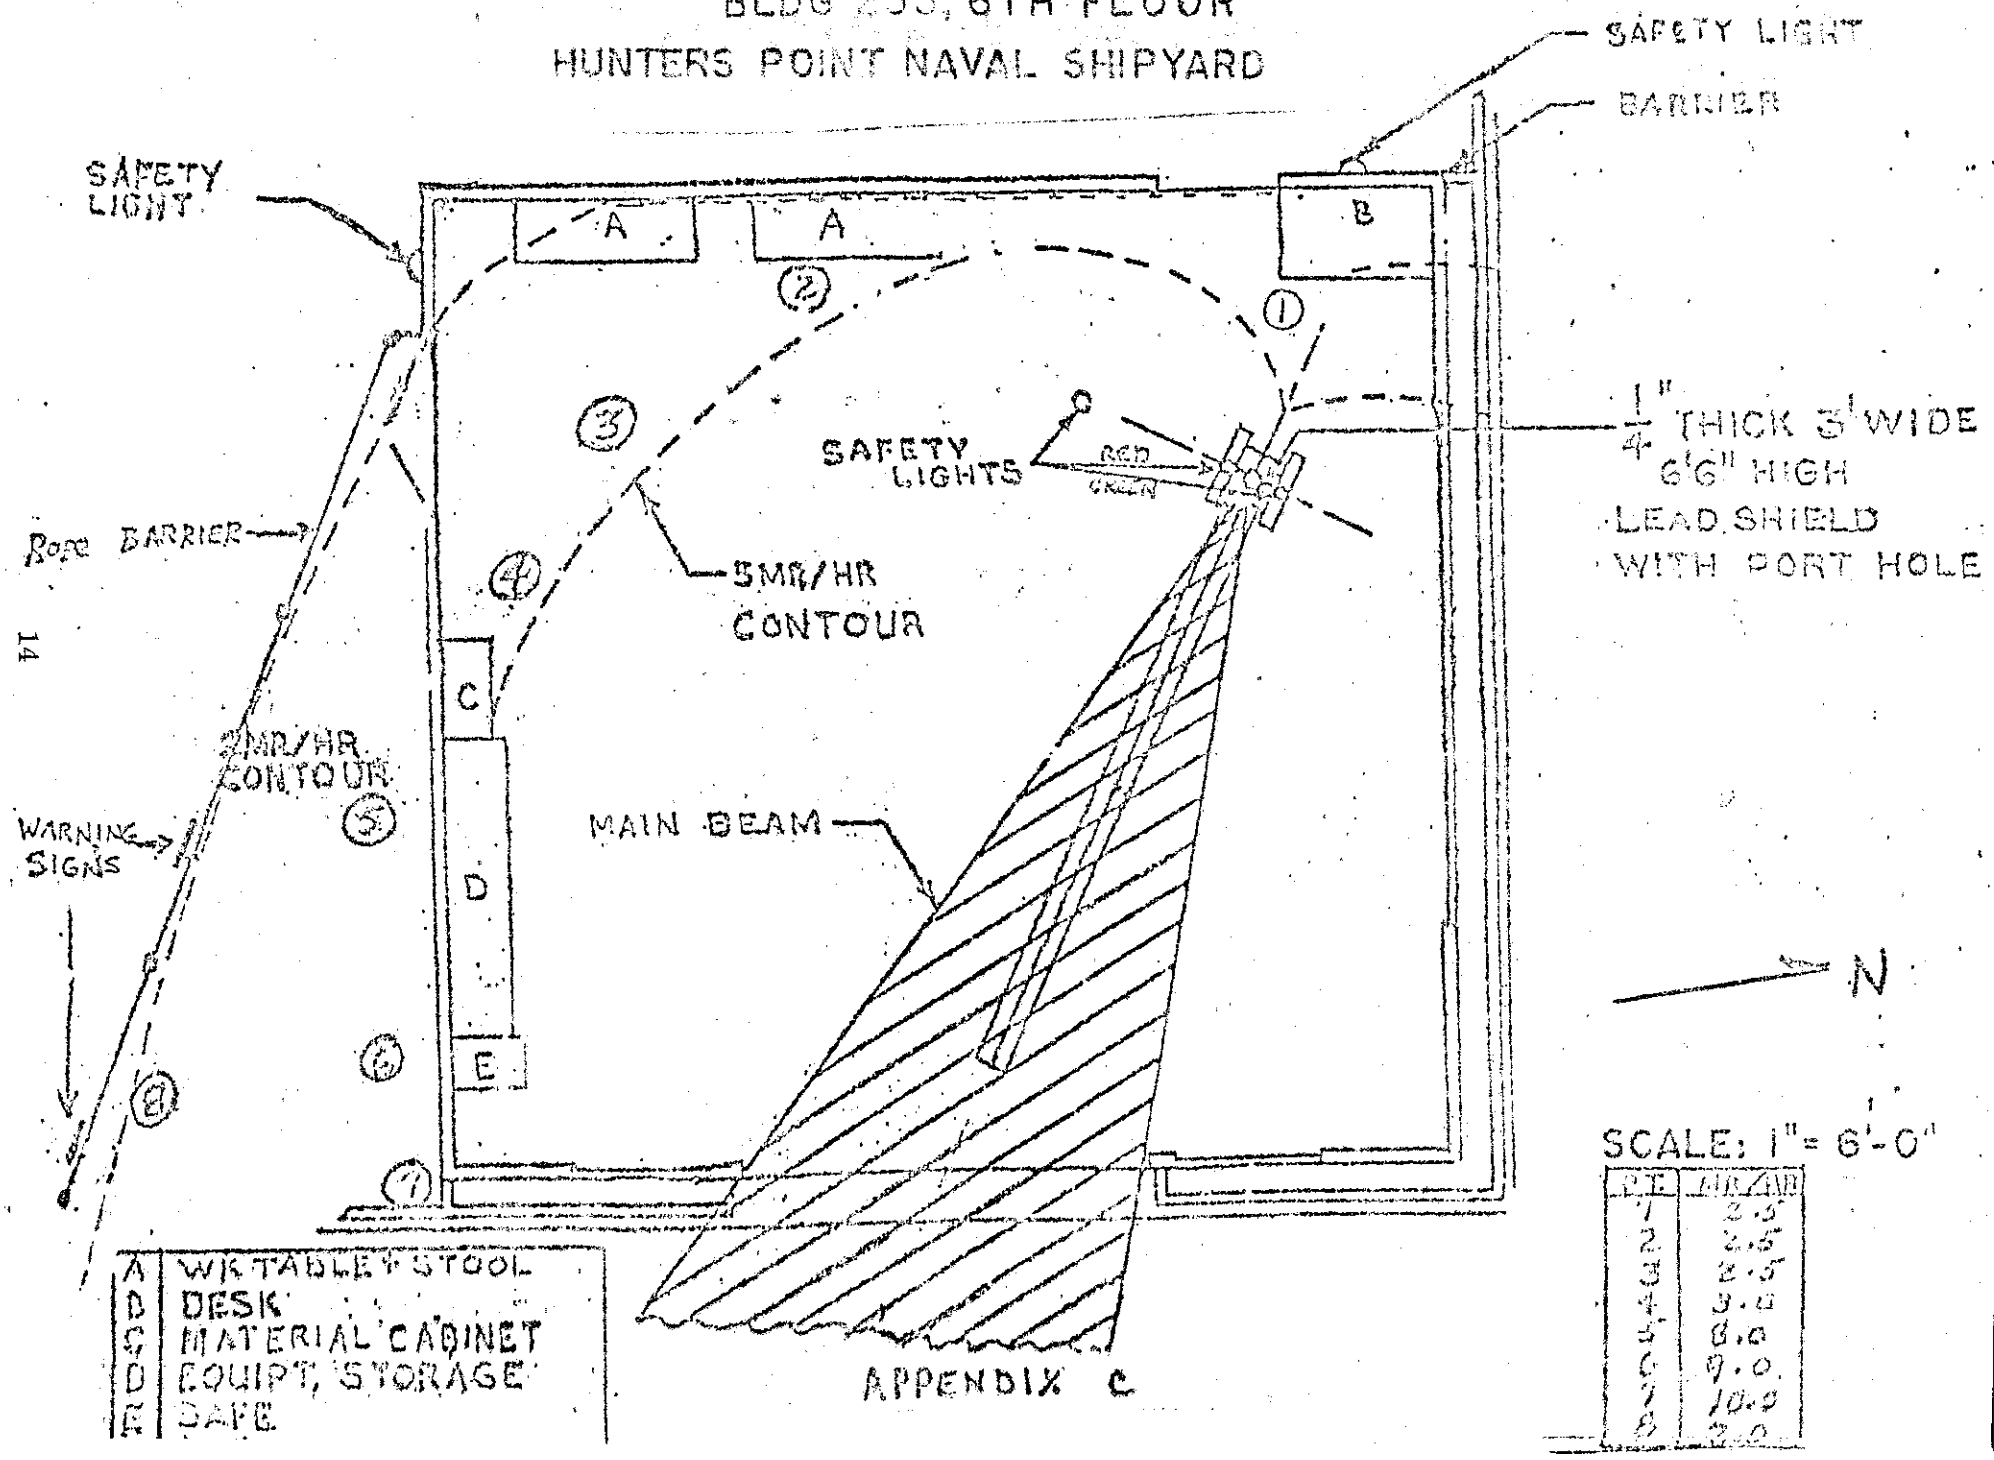
AN/UDM-1A CALIBRATION ROOM

a. The calibration range was a one room concrete structure located on the sixth floor (roof) of Building 253. The facility was equipped with a 130 Ci cesium-137 source and a 5 Ci PuBe source (AN/UDM-5). A survey of the AN/UDM-1A was performed and the results are included in Appendix C.

c. A lead shield was placed behind the AN/UDM-1A. The control levers were located at the operator's position behind the shield. Two status lights, located on the shield, were connected to the controls. A green light indicated the source plug was out and a red light indicated the source was exposed. Arrangement and floor plans of the calibration site are included in Appendix C.

PT	MR/HR
1	2.5
2	2.5
3	2.5
4	3.0
5	8.0
6	9.0
7	10.0
8	2.0
